Report To: Environment & Regeneration Committee **Date:** 18 January 2018

Report By: Corporate Director Environment, Regeneration and Resources **Report No:** LP/003/18

Subject: King George VI Building Phasing and Costs

Structural and Rot Survey

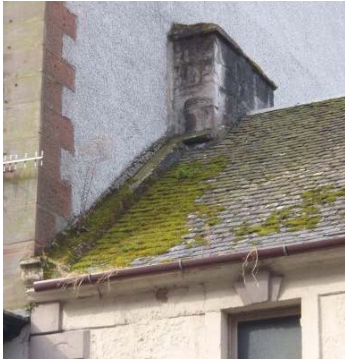
External Inspection – There are missing and damaged / loose slates and moss/lichen over both roofs. Slaters who have carried out work on the roof refer to them as suffering from nail sickness. There is a drop in the ridge over no 11, and a noticeable drop (with some spread) across the rear roof slope of no 11 alongside the rear access stairwell.

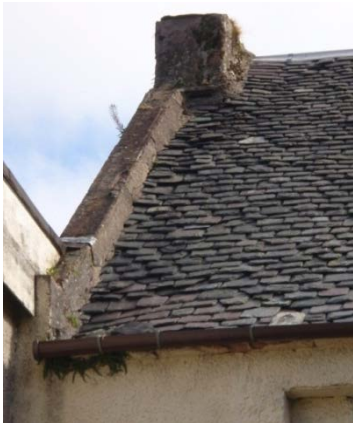
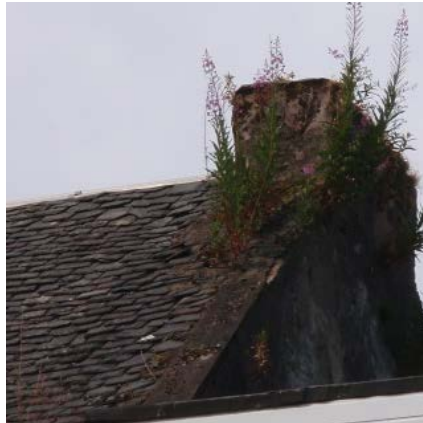
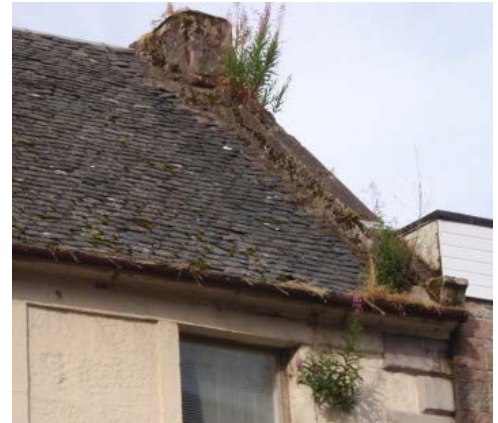
There are significant amounts of moss and lichen over the club skewes and flashings alongside the tenemental property. Damp staining is present across the face of the chimney adjacent to the tenement property with cracking and sections of loose / weathered stonework also noted. The chimney has been capped using slate and cement fillets.

New metal flashings and clips are present over both roofs and some have lifted slightly. Cement fillets appear to have been added recently and there is also remedial works and cement repairs to the party wall. Cracks are present across the fillets with gaps between the edge of the fillet and the projecting masonry. Localised repairs have been carried out to projecting weathered stonework. Moss and weeds are present in joints.

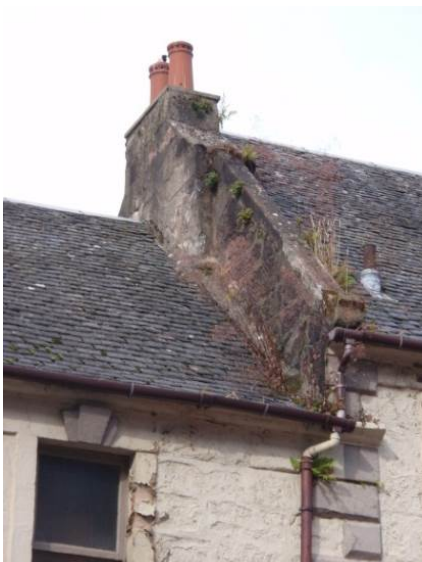
At the common gable, repairs have been carried out to the chimney head with new pots and precast capping stones. There is moss and weeds between joints and on the underside of the capping. No 11's right hand gable chimney has been capped. The pots have been removed and replaced by a cement covering. The cement fillets alongside the projecting gable stonework show damp staining and moss growth in open joints. Render across the projecting stonework and exposed gable is becoming loose and cracked.

Weed growth, blocked gutters and open joints in stonework

Gutters are choked, both front and rear, with plant growth and some sections are loose and have dropped. There is damaged and missing of flashings over the rear kitchen projection.

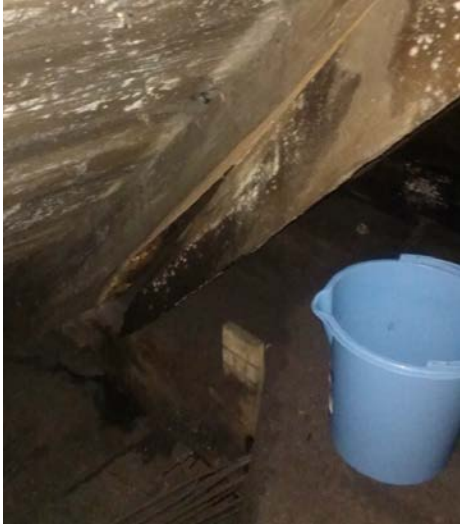
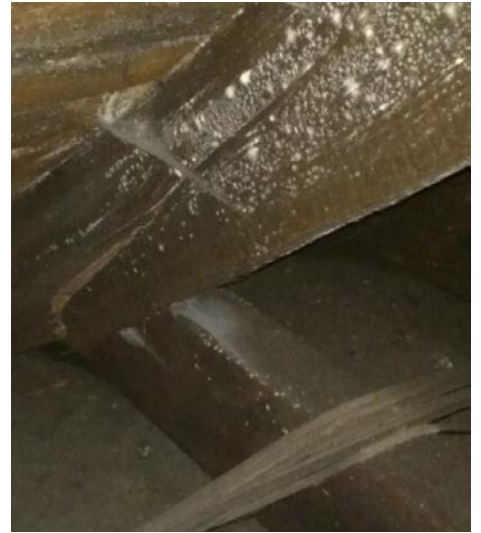
Internal Inspection – The roof structure in both No 9 and No 11 uses a raised collar type roof trusses with nailed joints. Damp staining and evidence of timber decay could be seen affecting the sarking boards and across the roof timbers. In no 11 there was some water ingress. As previously stated in no 11 there was damage to roof trusses with cracking and splitting of the timbers along rafters of both roof slopes, resulting in the roofs being temporarily propped. To a lesser degree there is some failure of roof trusses in no 9. It should be assumed from what is visible that the hidden joist ends with also suffer from rot.

As previously stated in no 11 there was damage to roof trusses with cracking and splitting of the timbers along rafters of both roof slopes, resulting in the roofs being temporarily propped. To a lesser degree there is some failure of roof trusses in no 9. It should be assumed from what is visible that the hidden joist ends with also suffer from rot.

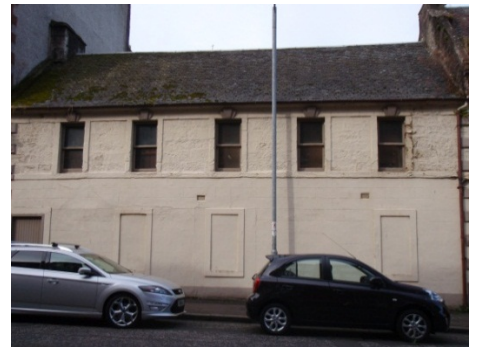
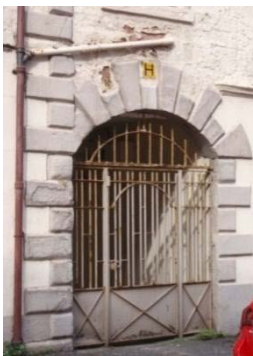
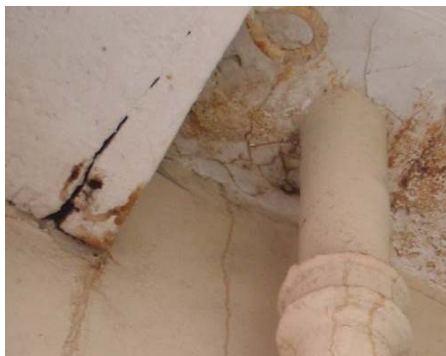
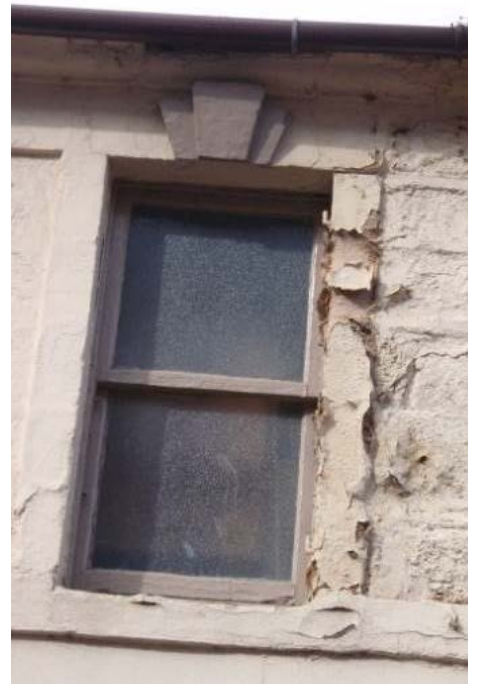
King Street Elevation

The front elevation showed evidence of weathering and movement and previous remedial works with mortar repairs. There is an outward bulge on No 9 (over the ground floor door opening and adjacent window opening with widespread cracking across the render. Cracking and loose render/ flaking paint affects lintels and cills, down the sides of windows and edges of stone dressings and along the stringcourse with damp staining and moss noted along the base of the wall. Ground floor window openings have been infilled. The stone arch is heavily painted and condition is thereby difficult to establish. There is cracking along the joints of some stones with loose stonework over the arch opening. The timber downstand beam alongside the stonework shows signs of timber decay. Weeds were growing between quoin stones and there is damp staining. At no 11 there were similar signs of movement and weathering across the front elevation with cracking through several window cills and lintels, extending down the wall, and damp staining and moss along the base of the wall. There was a slight drop in a ground floor window lintel and cracking and loose stonework. Window frames are heavily painted (painted shut) with evidence of rot.

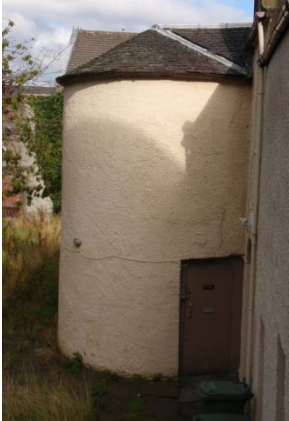
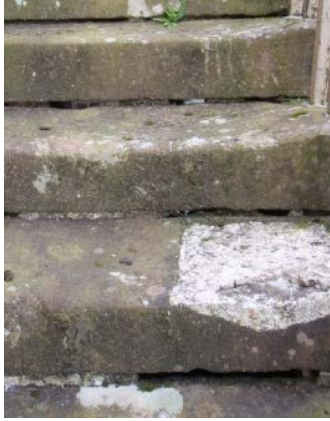
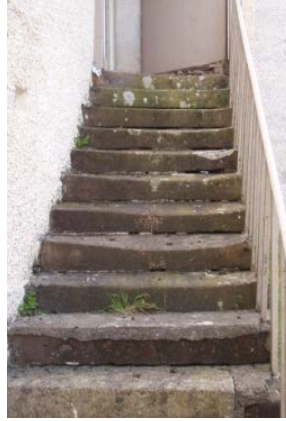
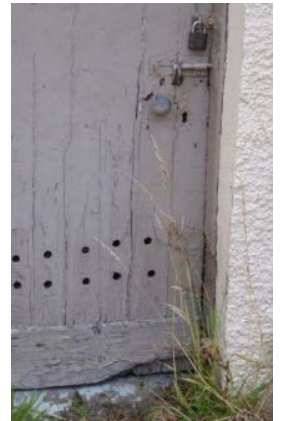
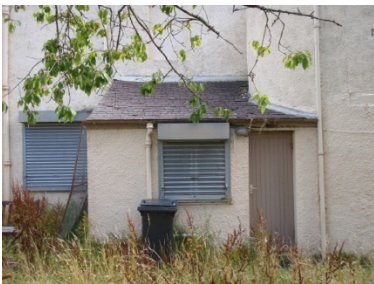
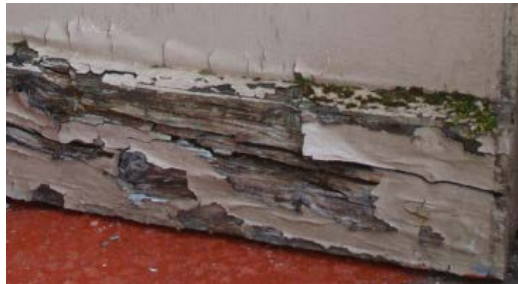
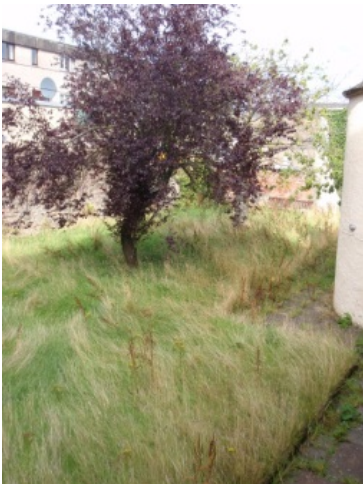
Rear Elevation

The walls have a painted wet dash render finish with signs of previous alterations and repairs. Some door and window openings i.e at 1st floor of no 11 have been infilled. No 9's bin store is in brickwork covered with stone slabs. A steel downstand beam gives mid-span support and shows significant corrosion. There is cracking in the masonry and gaps between the wallhead and the underside of landing slabs. There is timber decay across the lintel supporting the inner leaf and landing slabs. The external stair has broken / loose concrete and masonry with significant gaps between adjacent stones and supporting brickwork. There is corrosion across the balustrade and missing sections of steelwork. Some stonework has fallen off where the vertical rails have been cast into pre-formed packets in the masonry. There is evidence of localised render repairs across the main rear staircase tower. It has a slight bulge and an outward lean away from the rear elevation. There is hairline cracking across both no 9 and 11 and damp staining over the security shutters, at the junction between the rear elevation and the stair tower and at the base of the wall adjacent to downpipes. The masonry arch pend is heavily covered in cement. The timber lintel alongside shows signs of decay. The ground level alongside the rear elevation is higher than the internal ground floor level, which is likely to cause dampness.

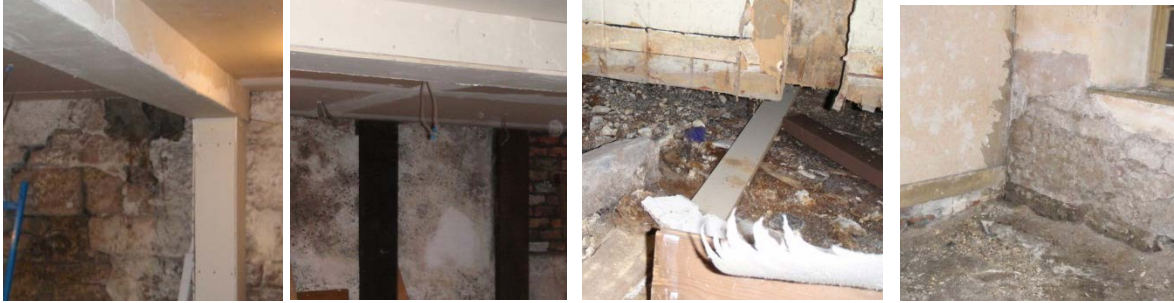
In the main store there has been previous remedial work carried out by the Masonic Lodge to provide additional support to their floor over. This included a downstand beam and steel column, which we understand has a concrete foundation. Due to work being covered at the time of inspection we were unable to make a judgement on the suitability of work carried out. Additional timber columns have been inserted supported from timber posts against the outer wall. There is cracking and open joints across the inner face of the perimeter and gable walls, damp staining and loose masonry. The floor is a combination of timber boards on soil/concrete with some sections loose. There is timber decay across the ends of first floor joists and woodsafe door / window lintels. In the smaller store there are signs of dampness, water ingress and timber decay across partitions and floor joists and boarding. The ground floor finish has been removed leaving an exposed solum and the spine wall partition suspended from the floor above. The ceiling has similarly been removed exposing the first floor joists. There are significant vertical cracks on each side of the door opening and loose sections of plaster and masonry show that there are no ties between brickwork & masonry.

Downstand beam & Column Additional timbers at Wall Unsupported Partition Exposed solum

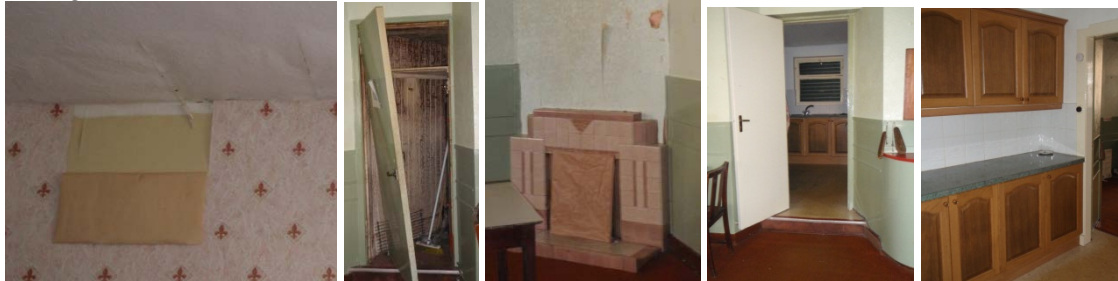
There are signs of water ingress with damp staining along the top of several walls and down interfaces of partitions. There is a fall in the flooring and extensive timber decay across floorboards. There were signs of timber decay to timber woodsafe lintels and joist ends. Some woodsafe lintels have been replaced with steel beams, which exhibit signs of corrosion. There is cracking over door openings and some door frames are out of alignment.

Peeling Wallpaper, some mould growth

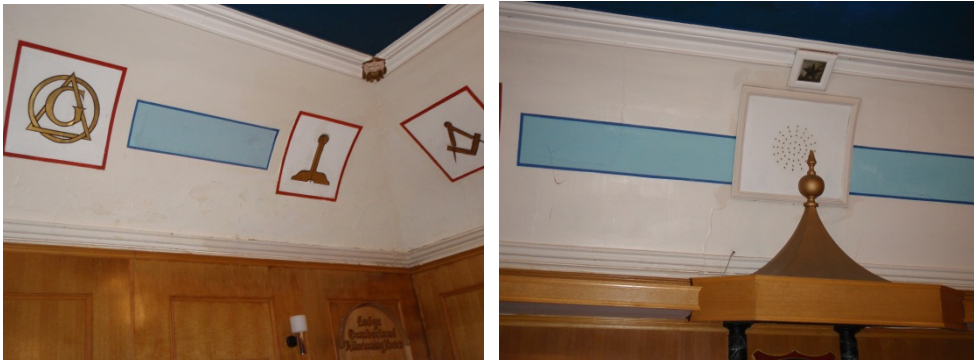
The Masonic Temple has wall panelling and a semi-vaulted decorative ceiling. At the party wall with no 11 there is damp staining and widespread cracking with evidence of past repairs. There was an inward fall to the floor adjacent to the anteroom.

Decorative cornice and panelled walls of Temple

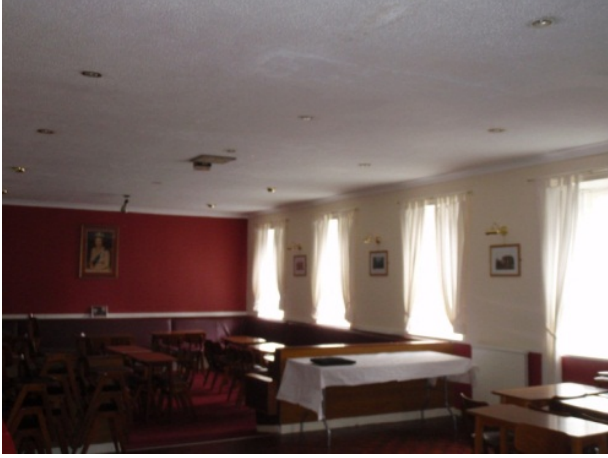
There is hairline cracking within the staircase with damp staining along the top of the wallhead and across the ceiling. The suspended ceiling in the lounge area was removed to allow for the props exposing the original semi-vaulted ceiling, which has some damp staining. At the common gable wall there is dampness cracking and loose plaster.

Lounge area prior to installation of props

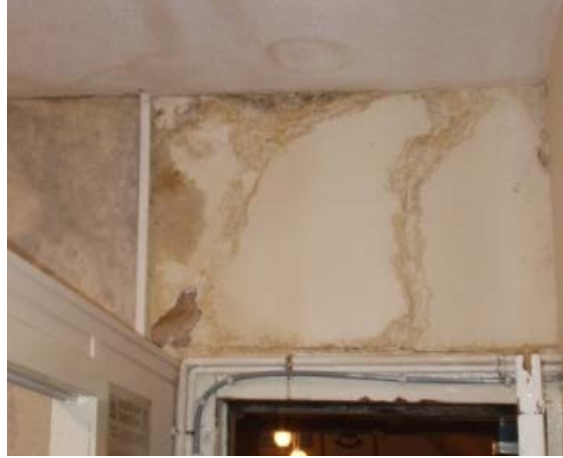
Damp at common gable
