Report To:	Environment & Regeneration Committee	Date:	29 October 2020
Report By:	Corporate Director Environment, Regeneration & Resources	Report No:	ENV/029/20/AM
Contact Officer:	Alan McClintock	Contact No:	01472 712444
Subject:	Comet Replica – Condition Survey

General Condition Survey

Comet Replica

Project No: 2090/00

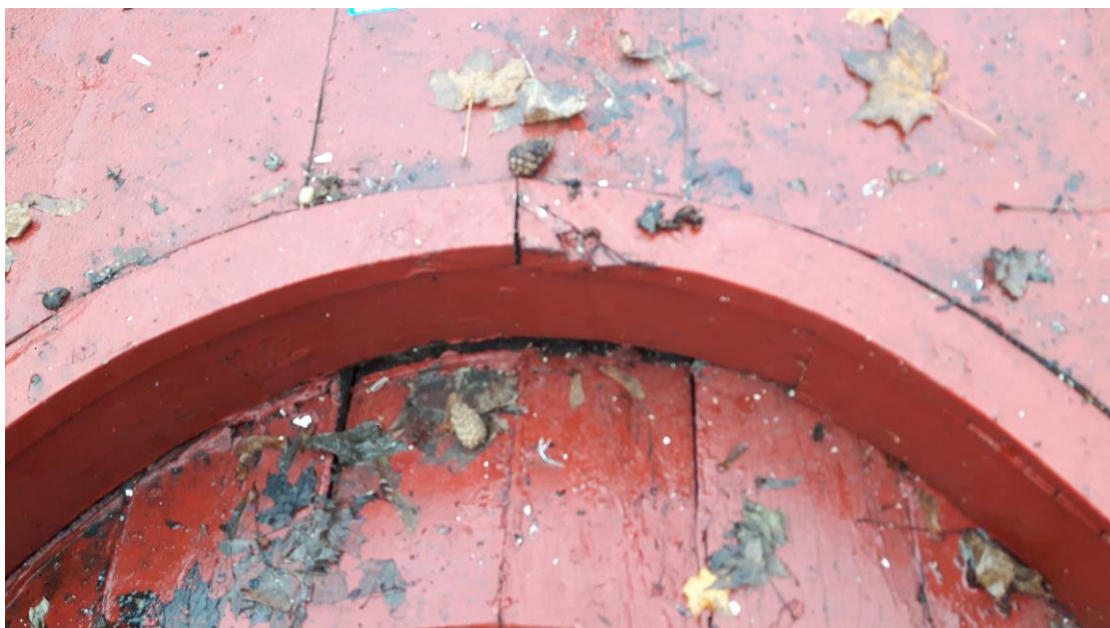
Aft cabin is accessed from the main deck via recessed semi circular steps. There is a deck house over the cabin, The access steps are rotten and the deck head of the deck house has collapsed. The original main deck planking has been replaced with plywood at some point, the ply wood is completely rotten in some places and it is possible to go through the deck as the wood is so rotten. There are mould spores throughout the aft cabin. The vessel was completely covered with a canvas type cover from the top of the bulwarks. There has been no air circulating through the aft cabin or any part of the hull other than those areas of the hull where the hull planking has rotted away/been smashed, thus allowing air in.

Plywood main deck and aft cabin access steps

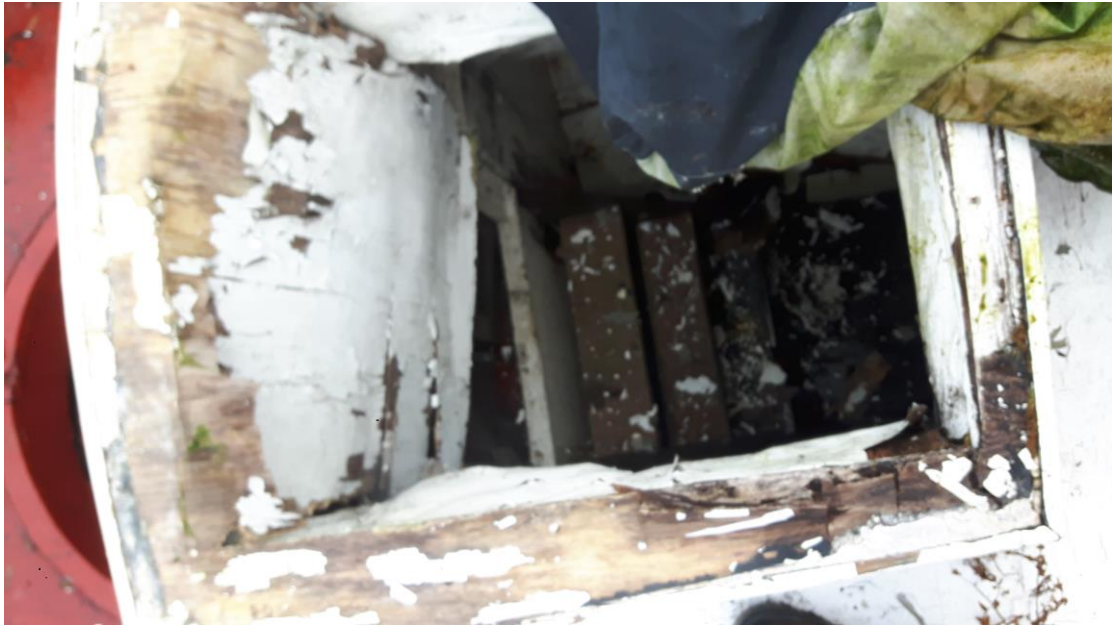
Aft cabin rotten collapsed deck head

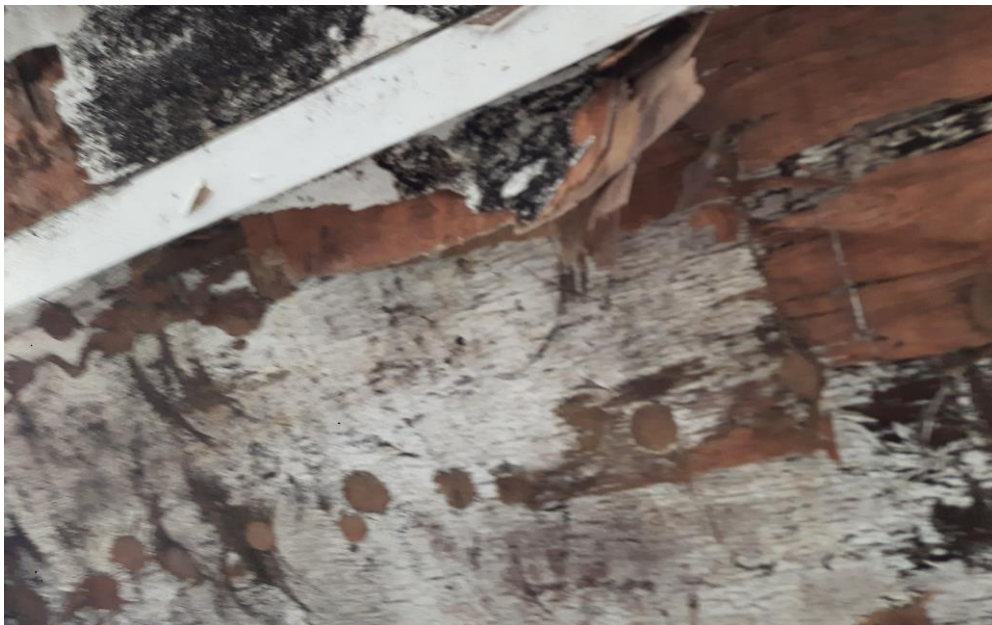
Aft cabin deck head

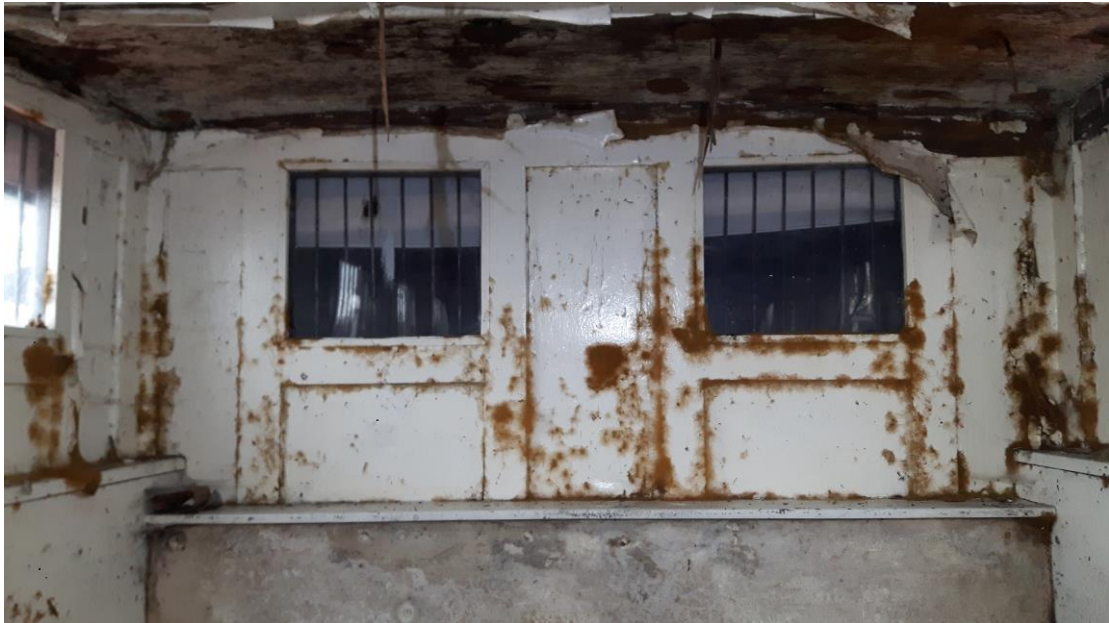
Aft cabin deck house – mould spores

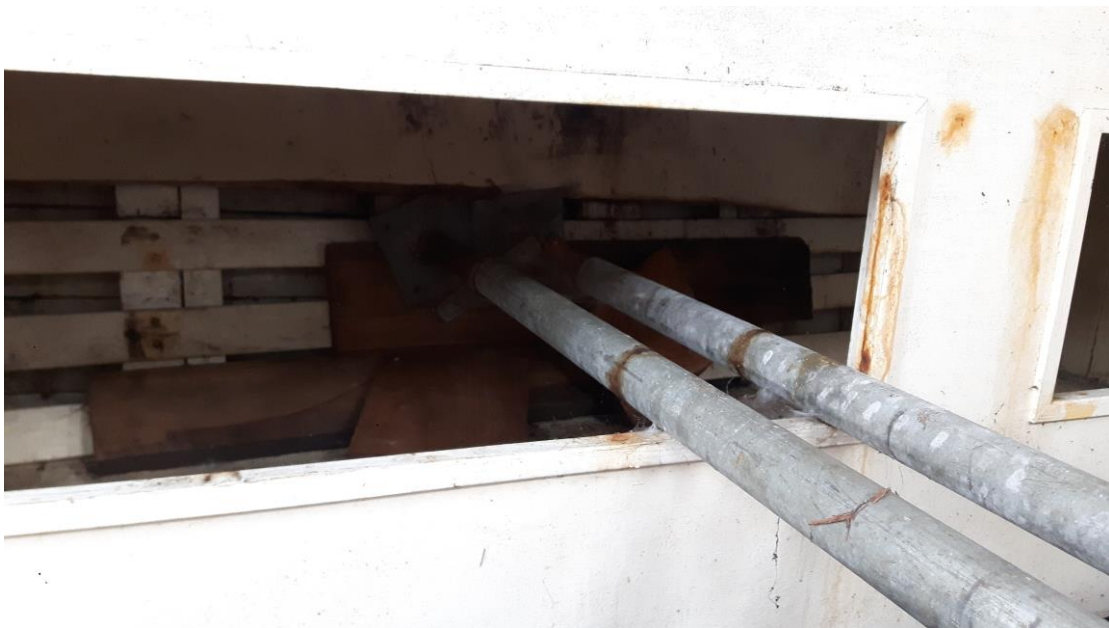
Aft cabin, scaffolding poles – possibly left from last maintenance period

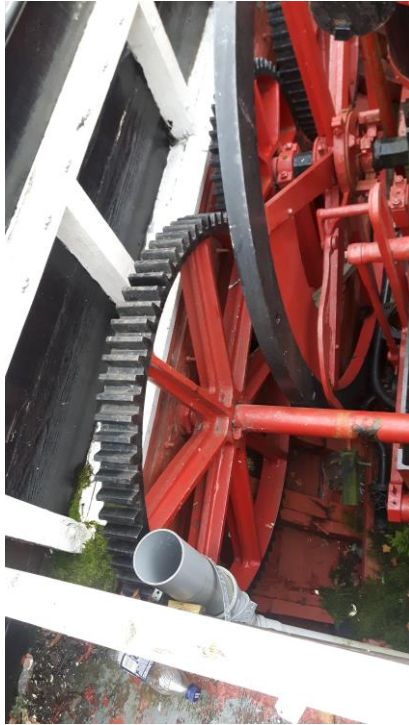
The machinery has not been run since the 1960's and is all completely seized. The after gear wheel for the aft paddle no longer meshes with the engine driven gear wheel and all driving gear wheels are out of alignment, possibly due to the machinery foundations being rotten and the twist in the hull. Timber bearings in the hull for the paddle shafts are all rotten.

Engine room looking aft

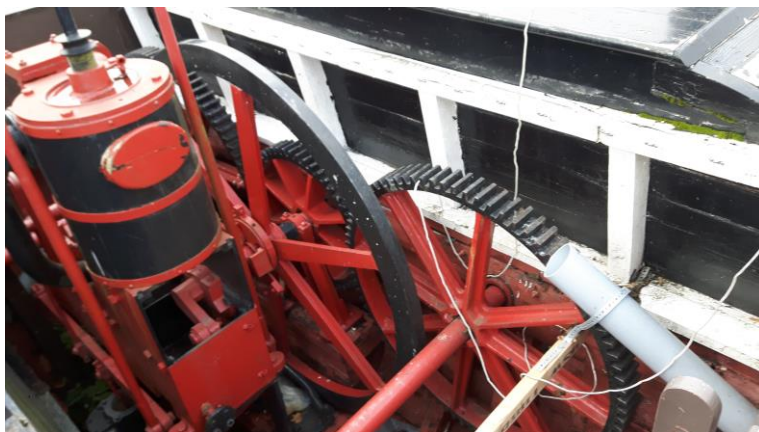
Engine room looking forward starboard side

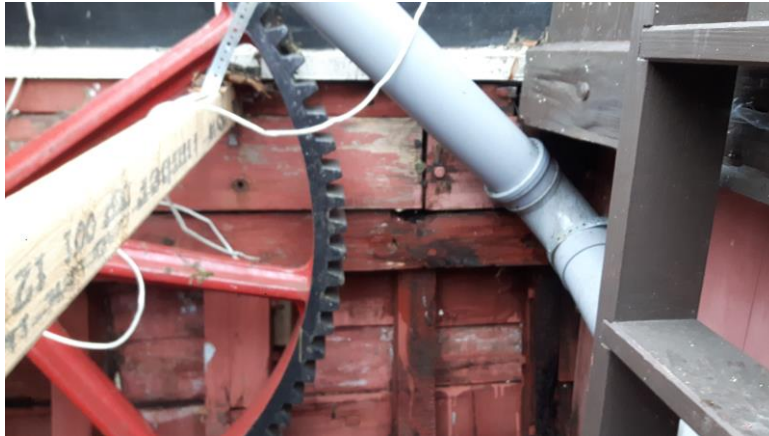
Engine room Aft Starboard, rotten beam shelf and rotten beam shelf stringer

170mm x 50mm, beam shelf stringer 130 x 50mm, rotten midships.

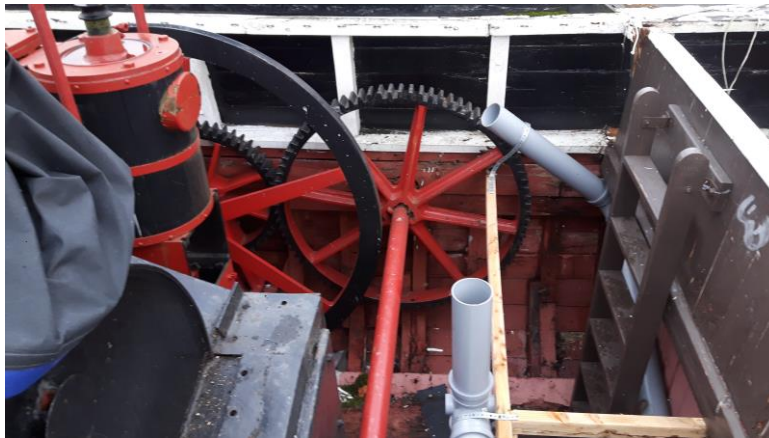
Engine room aft starboard, rotten detached bulwark

Coamings/bulwark is fitted in way of the open area of the engine room, these are rotten and detached from the bulwarks starboard aft, they should be replaced.

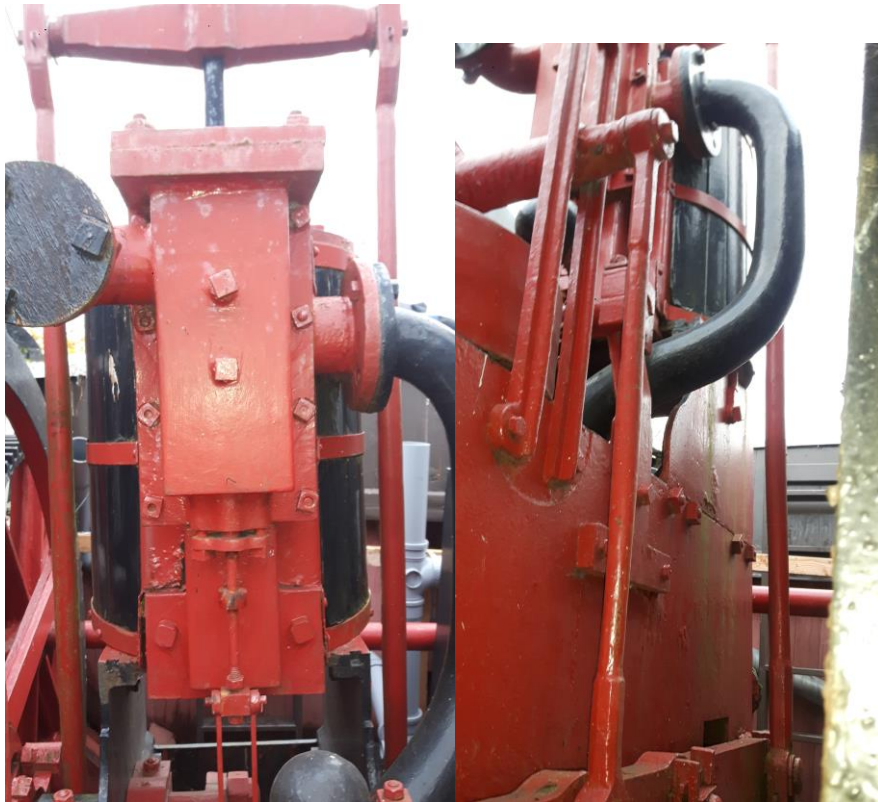
No machinery was run during the survey, the steam engine is completely siezed.

Single Cylinder Steam Engine

The main engine is a John G Kincaid single cylinder steam engine, powered by a saddle type boiler. Engine is completely seized. It is thought the engine, boiler, paddles and gearing could be removed from the vessel and fitted in a new replica, the boiler, engine, paddles etc would require stripping, cleaning, preserving and reassembly to ensure longevity. While it is probably not worth returning the machinery to working condition it is definitely worth returning the machinery to display condition, possibly having the machinery (engine and paddle wheels) driven by an electric motor.

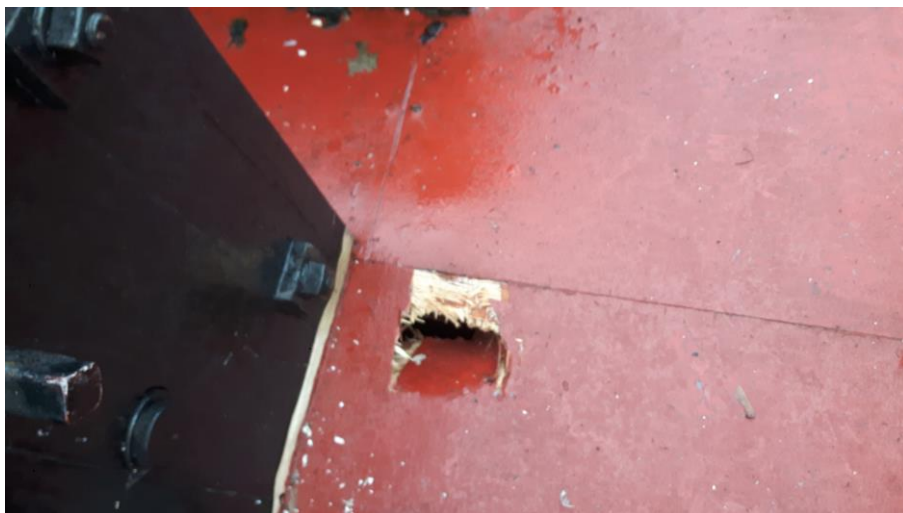
There was no access to the forward cabin. There was no ventilation to the forward cabin, the main deck above the forward cabin is particularly dangerous and it is easily possible to step through the main deck plywood.

Rotten ply wood deck forward.

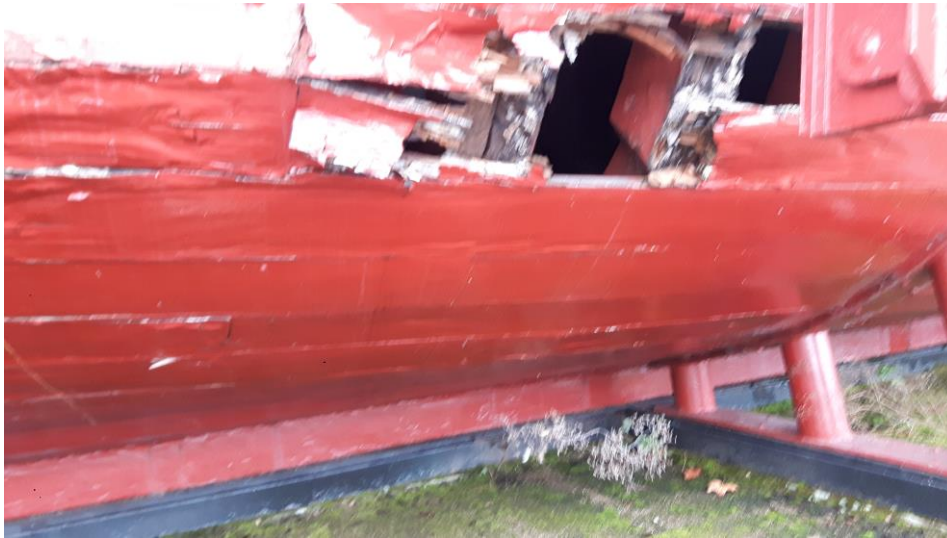
Rotten planking port side

40mm throughout, very rotten, short lengths of planks and some planking completely disintegrated.

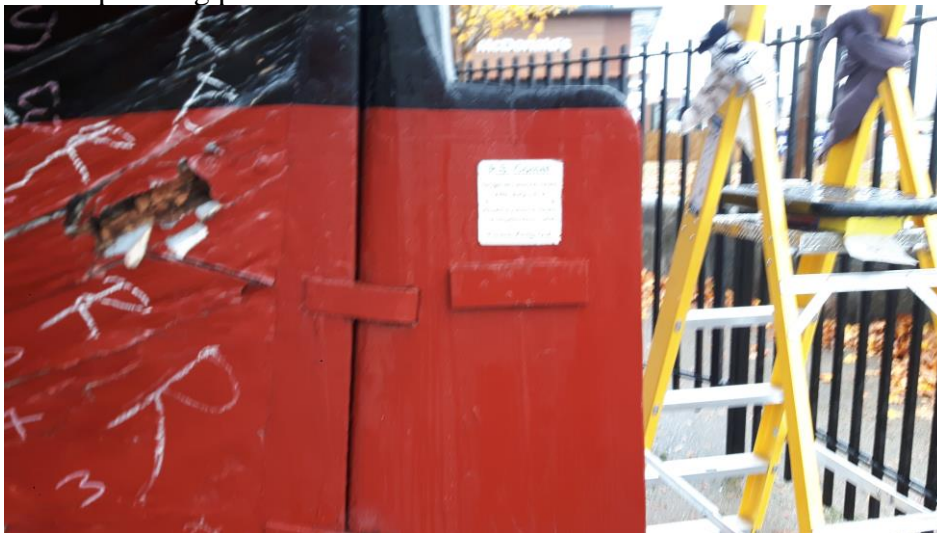
Rotten planking starboard side

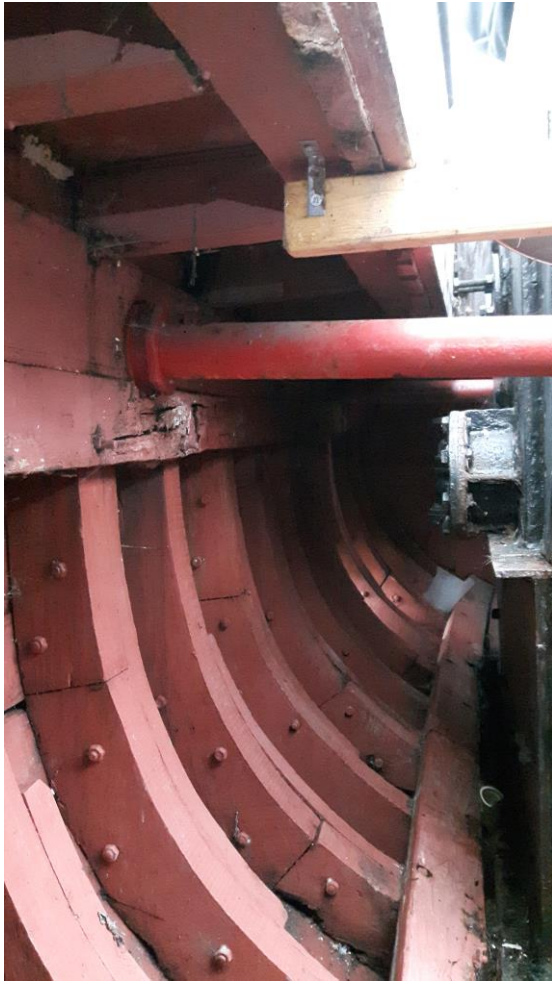
Framing in the engine room, rotten bilge stringer, rotten beam shelf, rotten beam shelf stringer

150mm x 50mm, rotten midships

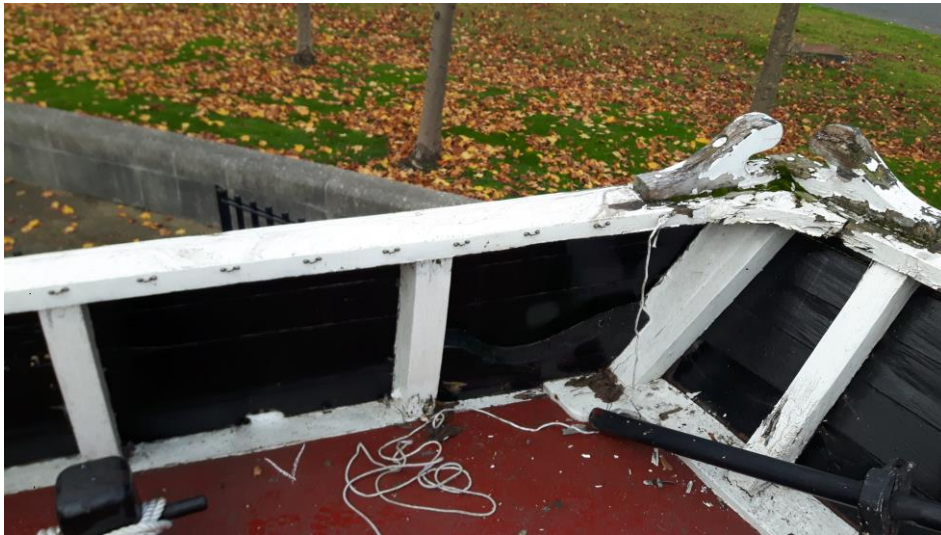
Bulwarks aft

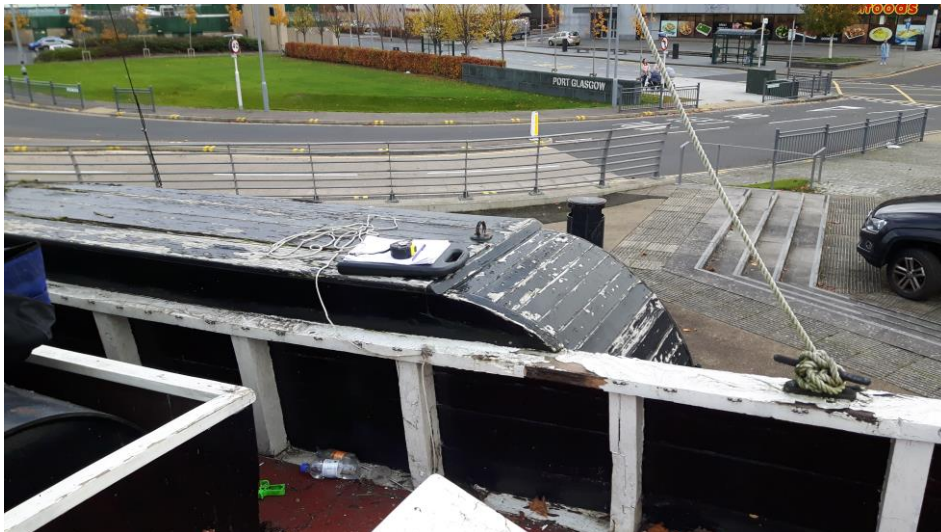
Bulwarks port side

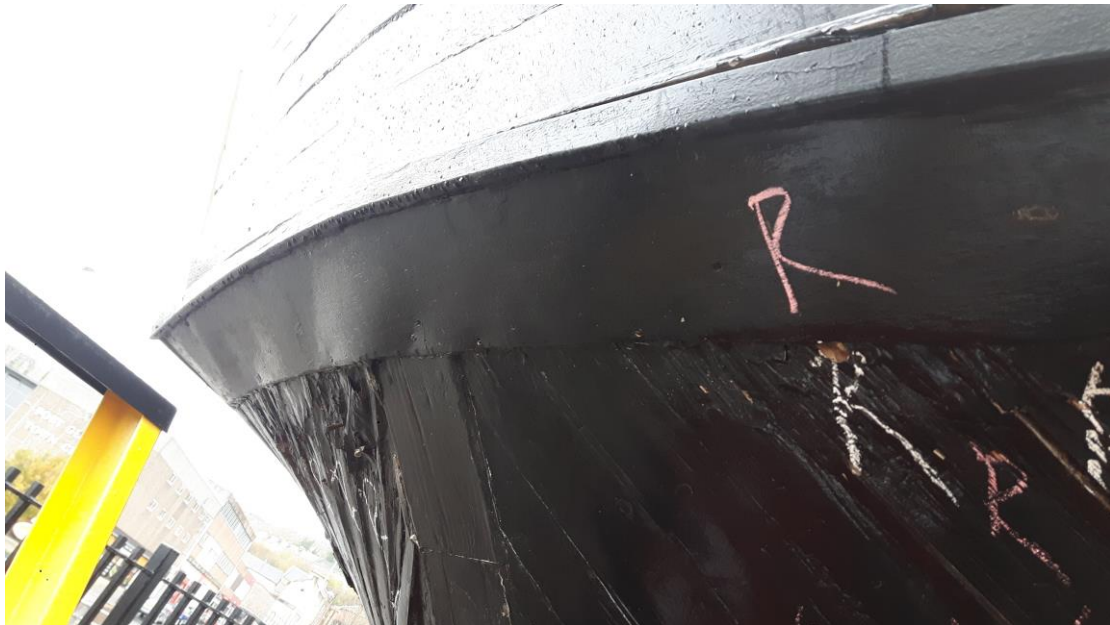
All coatings are in a poor condition with flaking paint, structure under the coatings are in such poor condition, the coatings are irrelevant.

Typical coatings and plywood strip to keep planking in place in the stern

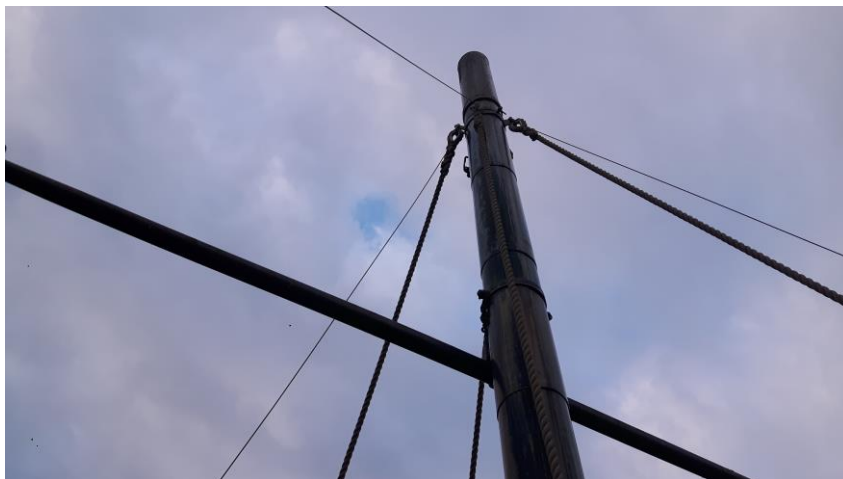
The main mast is the funnel, the mast is bent and is leaning to port. One yard for the square sail fitted to the funnel, no access to inspect it. Yard should be secured so that there is no possibility of it falling. Funnel has four rope stays to the bulwarks, no reliance should be put on these stays due to the poor material condition of the vessel. There are also four stays from the perimeter fencing attached to the funnel, they were quite taut, however there is no maintenance history for the any of stays so it is essential they are all replaced so that there is no possibility of the funnel falling down.

Mast/funnel and yard

Action Replace all funnel stays as soon as possible

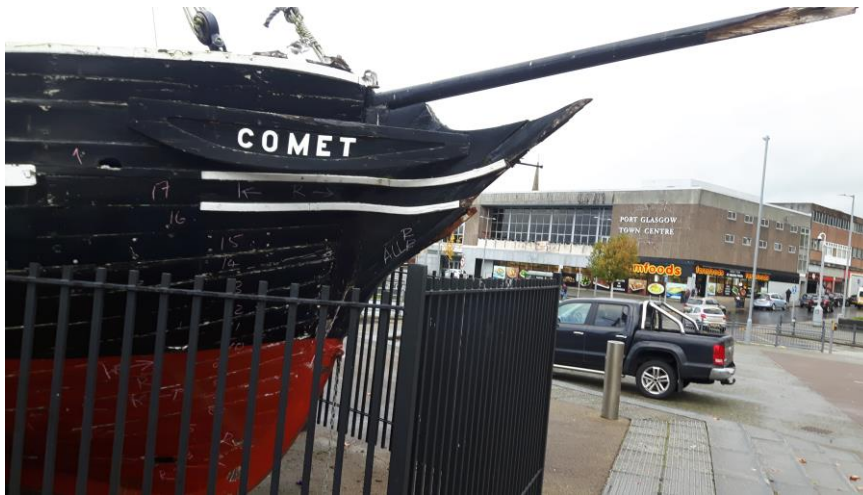
This has partially broken off and the remaining part is rotten, again this should be secured/trimmed so that no rotten part can fall off and injure a passer by/member of the public.

Broken bowsprit/jib boom projecting over perimeter fence

In the immediate term the major risk would be from a part falling from the vessel and injuring a member of the public, to this end it is important to secure or remove the bowsprit/jib boom, replace the funnel stays and secure the square sail yard to the funnel.

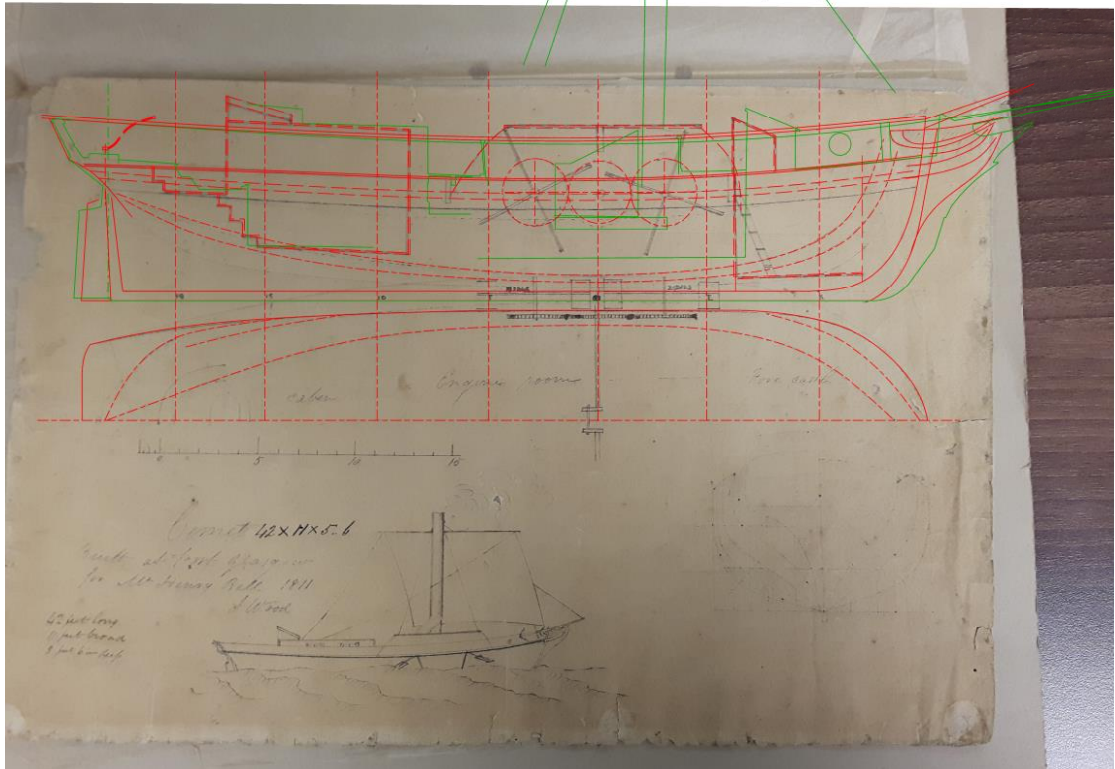
Drawing 1 from Glasgow University Archives, original drawing outline in red laser scan outline in green. Replica is close but a bit longer than the original vessel (if in fact the replica was based on this drawing).

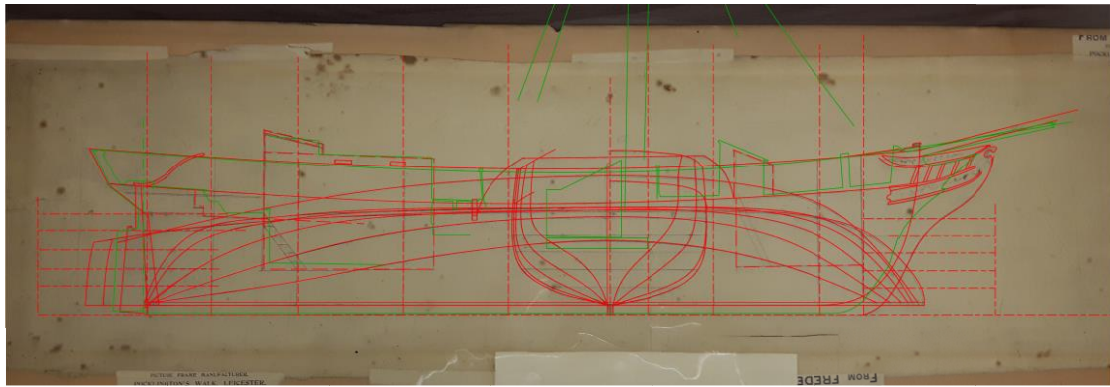
Drawing 2 from Glasgow University Archives, original drawing outline in red laser scan outline in green. Replica close but a bit shorter than the original vessel (if in fact the replica was based on this drawing).
