Report To: Environment & Regeneration Committee **Date:** 14 March 2024

Subject: Former Clune Park Primary School / Clune Park Church

Project Number: 23.1190
Project Title: Clune Park School, Port Glasgow

Project Number: 23.1190
Project Title: Clune Park Church, Port Glasgow

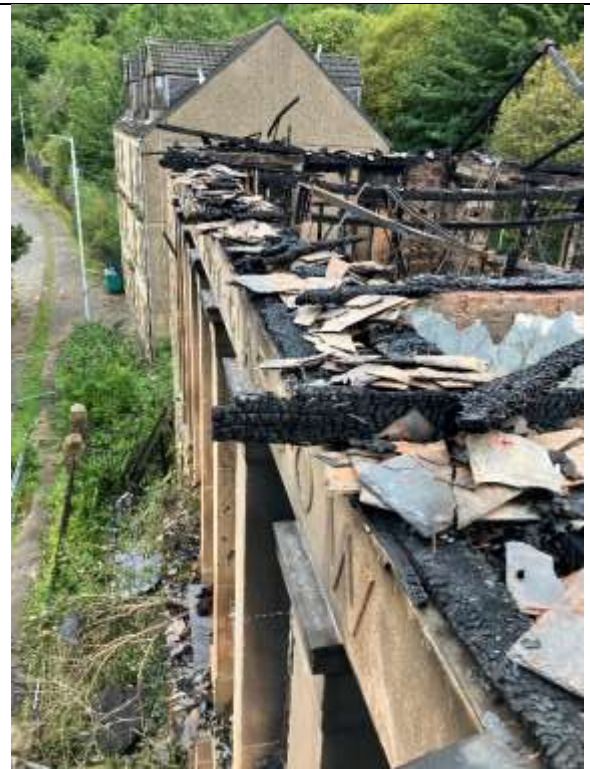
Wall Head of North Elevation

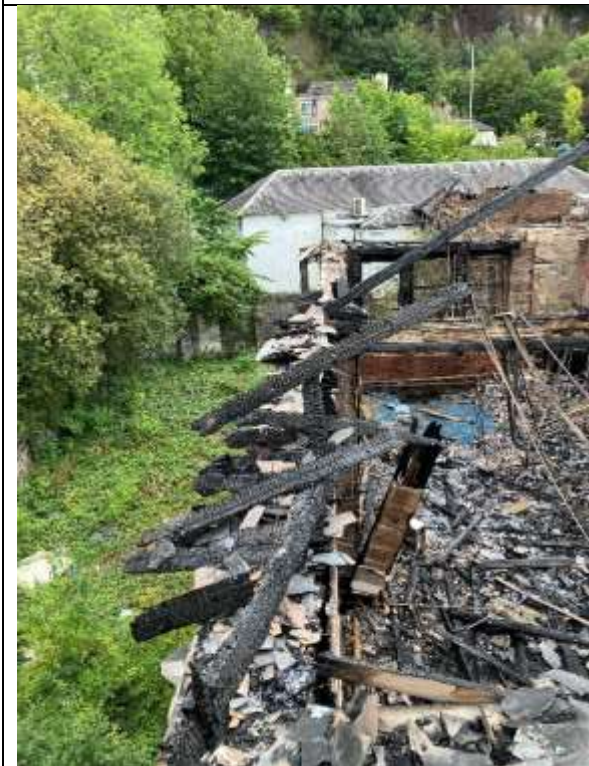
Wall Head of East Elevation

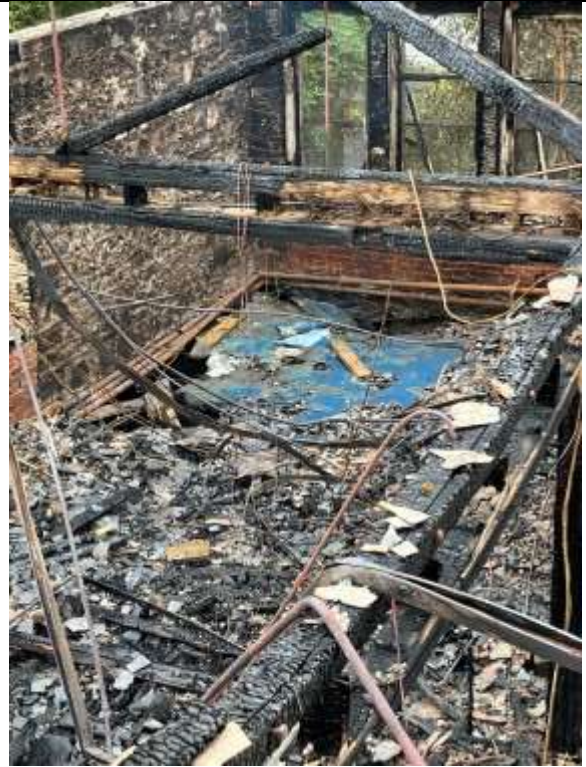
First Floor Collapse in Southeast of North Wing

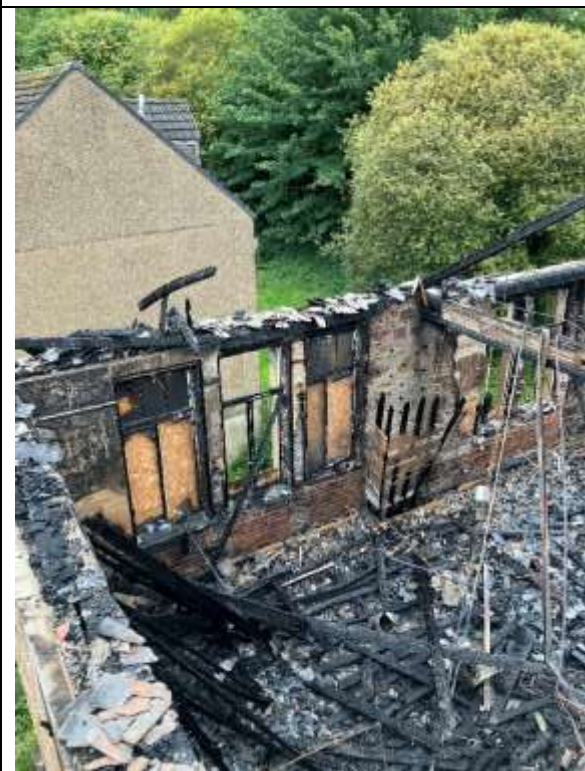
- 3.3 The fire left the building badly fire damaged. The roof, especially over the north and central wings, had entirely collapsed, with extensive debris left resting on the first floor below. The remnants included charred timbers, slate, and buckled metalwork. The timber header surrounding the perimeter was charred and fragile, and the large timber lintels behind the pilastrade windows at eaves level suffered significant charring and structural damage with lack of bearing on the masonry jambs. Two masonry triangular projections above eaves level were left unsupported and posed a potential hazard. Appendix 2 contains photographs that record the condition after the fire.

Roof Debris on First Floor

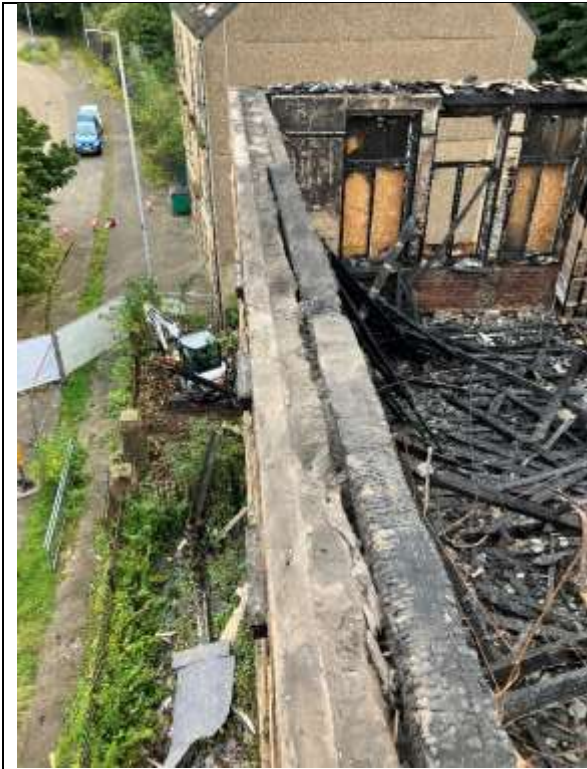
North Wallhead Cleared

- Removal of all loose debris along the wall head of the external and internal wall to reduce the risk of falling debris;
 - Removal of fire damaged timber wall plates;

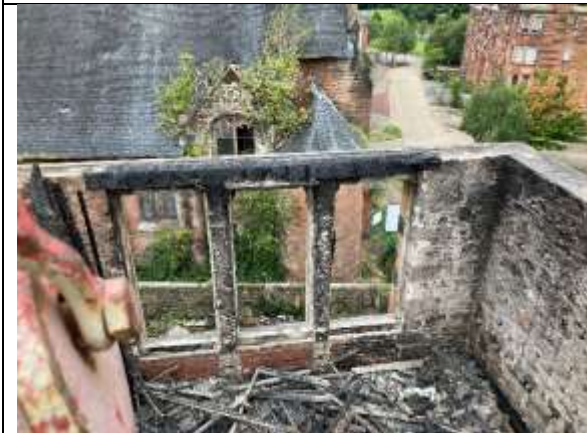
Charing to Lintel

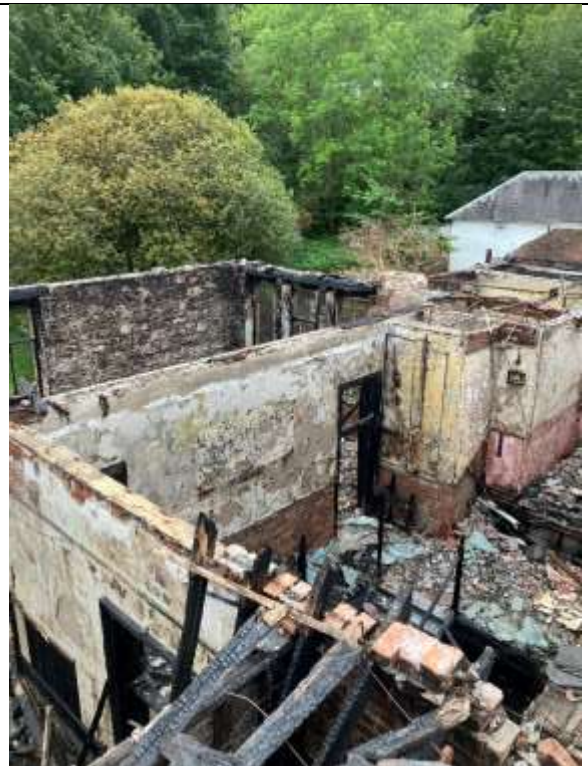
Debris and Loose Masonry to Internal Wall

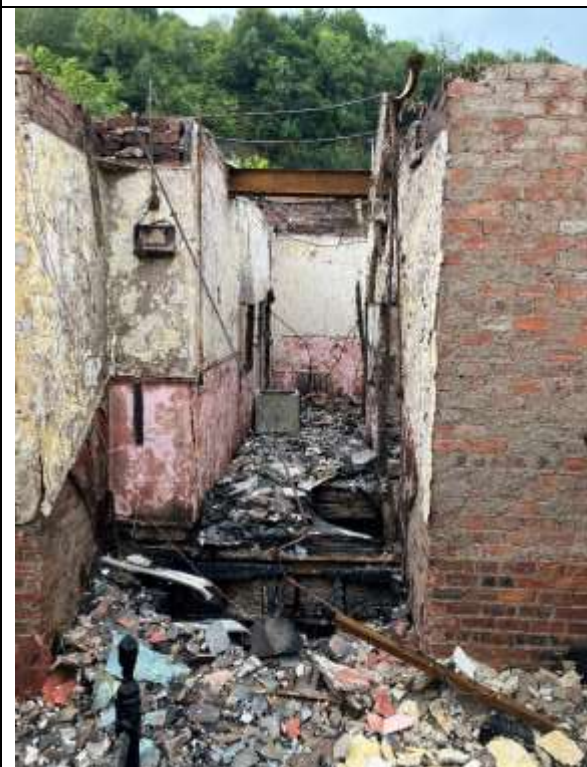
Corridor Looking South Showing Movement

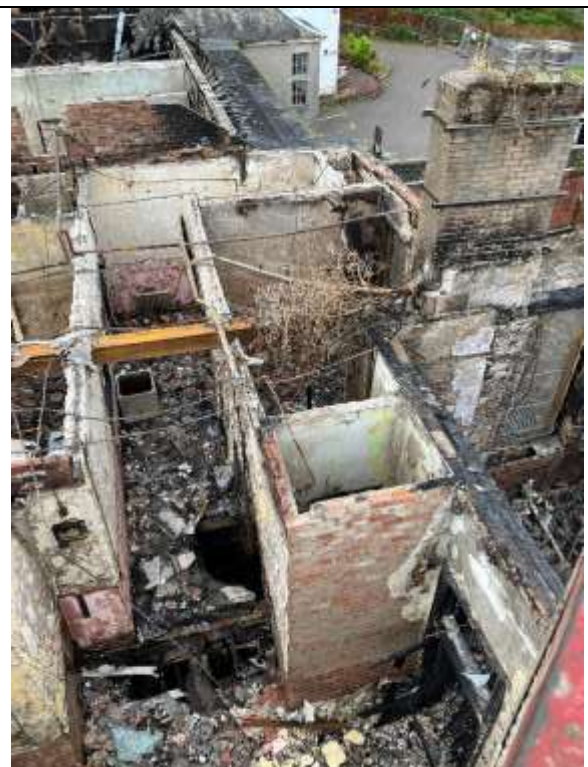
Cellular Walls With Lateral Movement

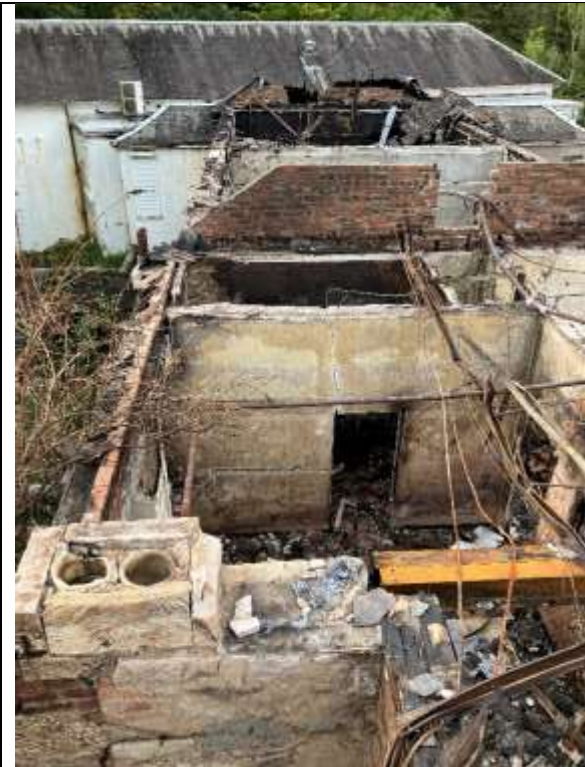
Movement and Cracking of Cross Wall

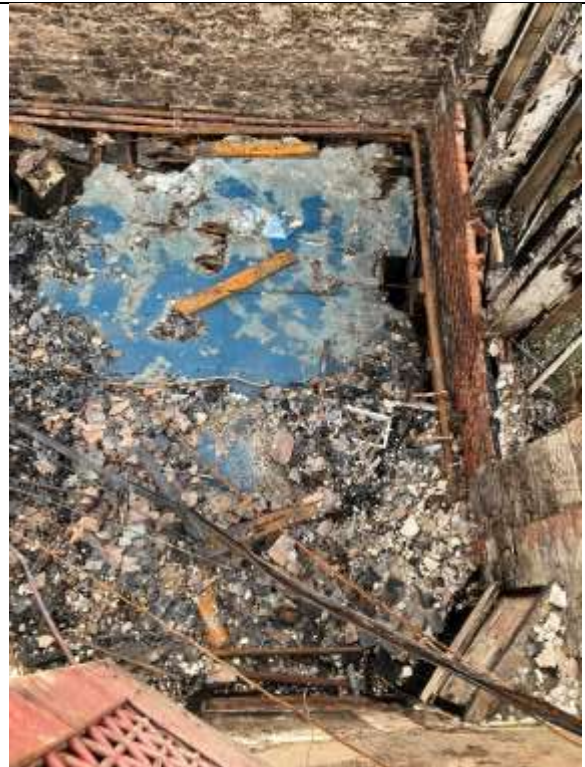
Damaged Floor

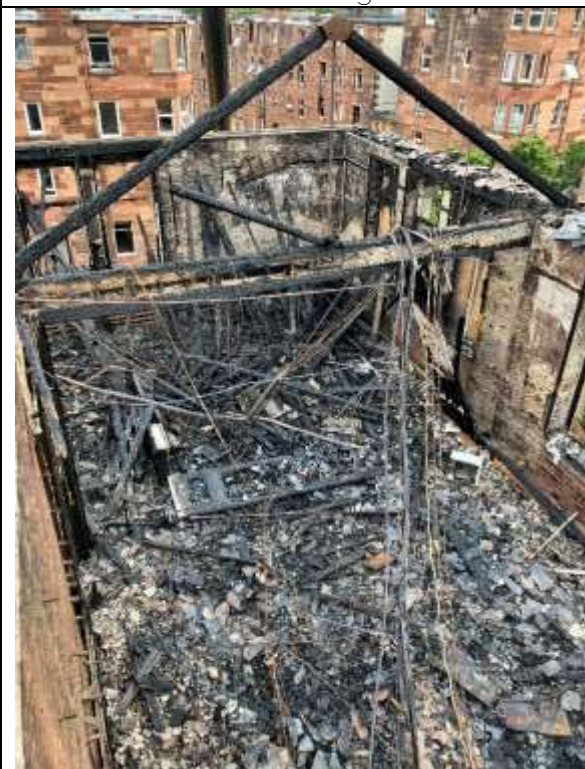
Roof Debris in North Wing

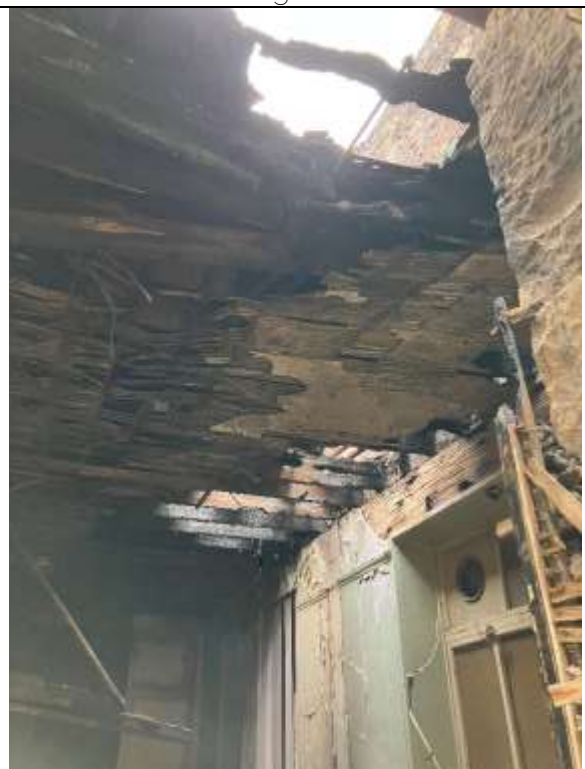
Floor Damage from Below

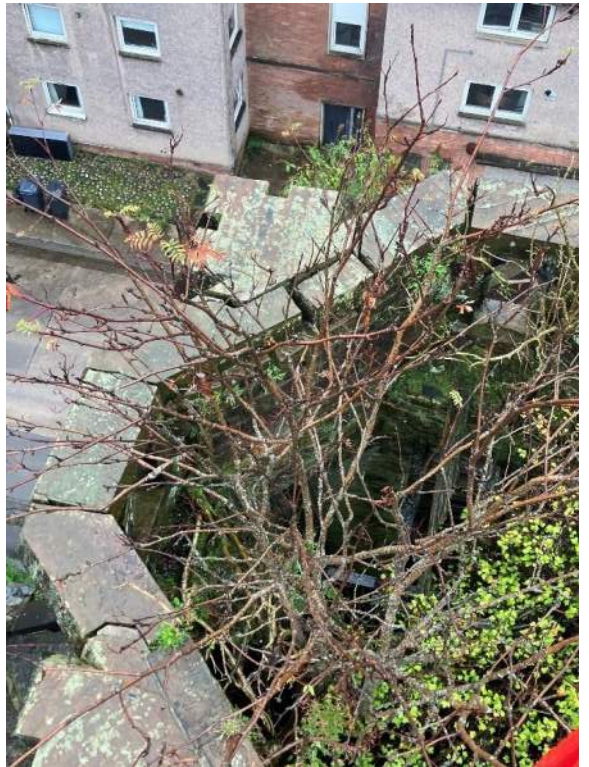
Movement of Stone Parapet

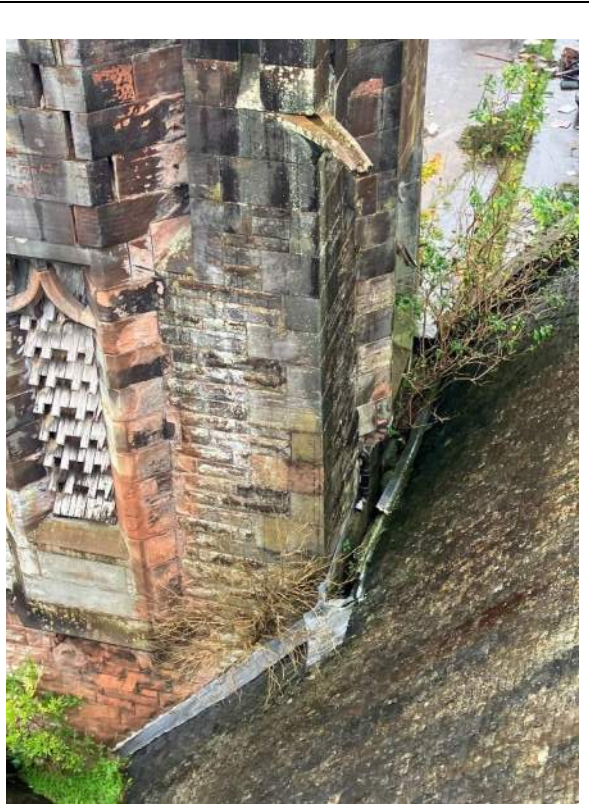
- 3.13 The building has deteriorated over 25 years and the partial roof collapse exacerbates the deterioration of some aspects of the building in particularly the north of the roof and transepts. The roof in this location would have also offered lateral support to the tower and transept wall heads which is now compromised. The active water ingress in multiple locations and the saturation of the entire structure is one which would need significant investment over a period to remediate. The exposure to the elements from the roof collapse will increase the rate of deterioration and will result in localised and progressive failure if no works are carried out. Appendix 3 contains photographs from the engineers report.

Roof and Tower Intersection

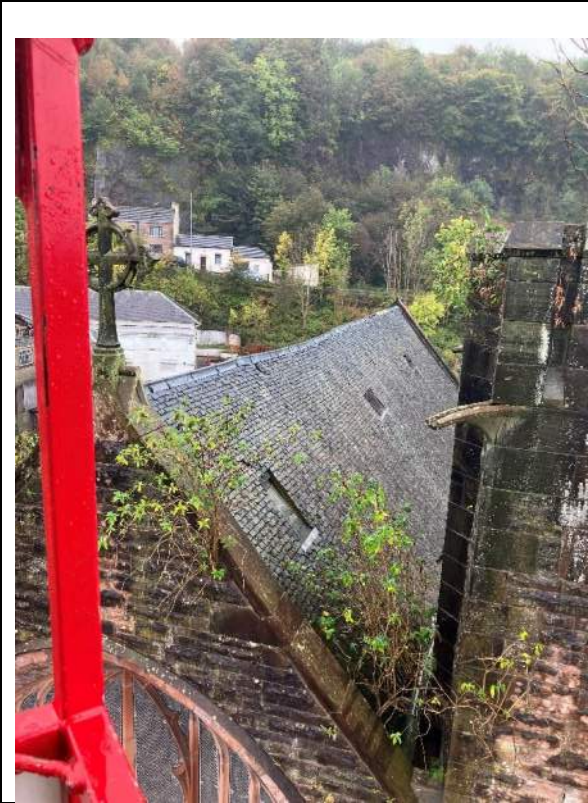
North Elevation Showing Vegetation and Apex Deflection

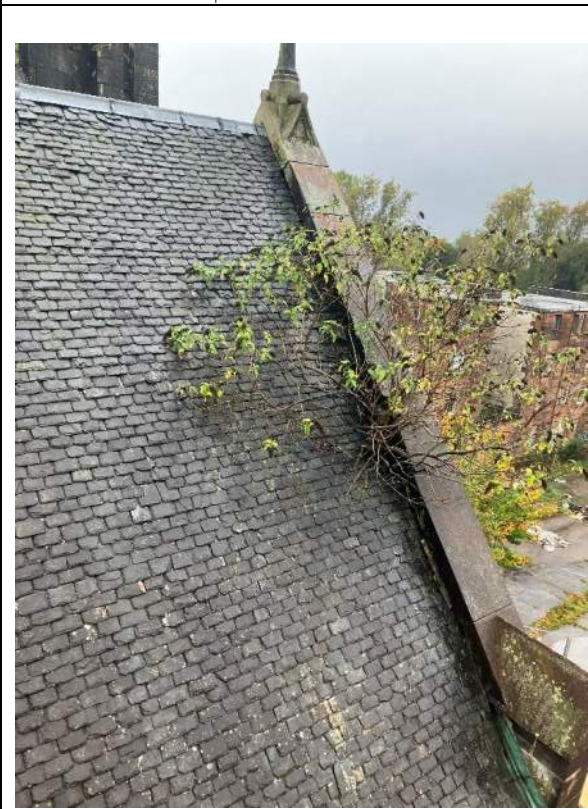
Tree Growth and Missing Flashing

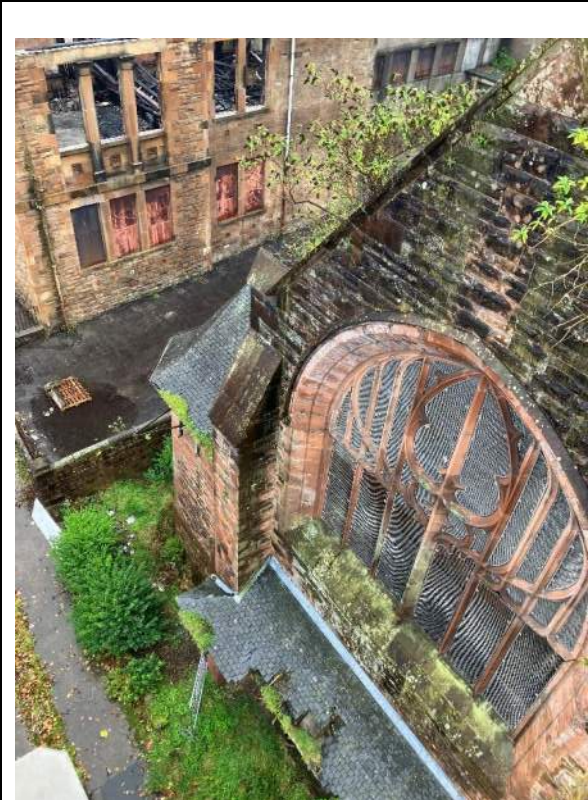
Vegetation Growth and Saturated Stone

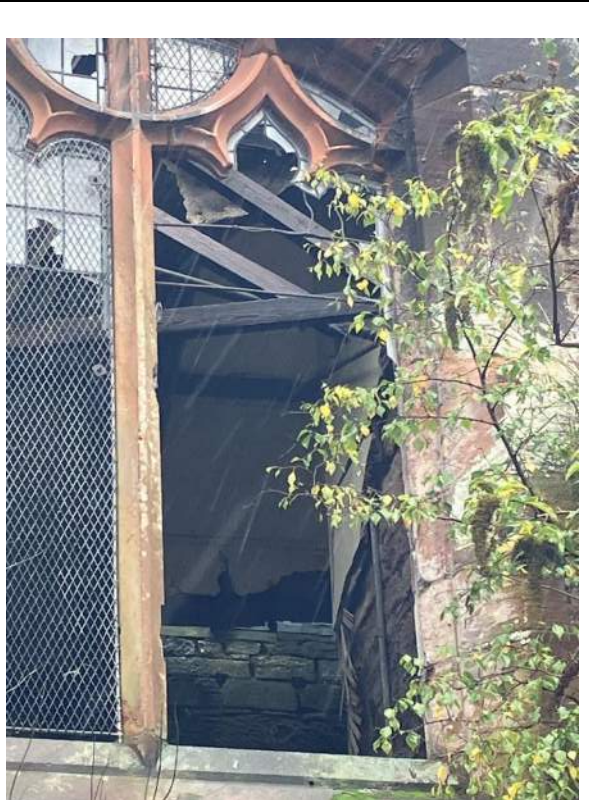
Partial Internal Roof Collapse

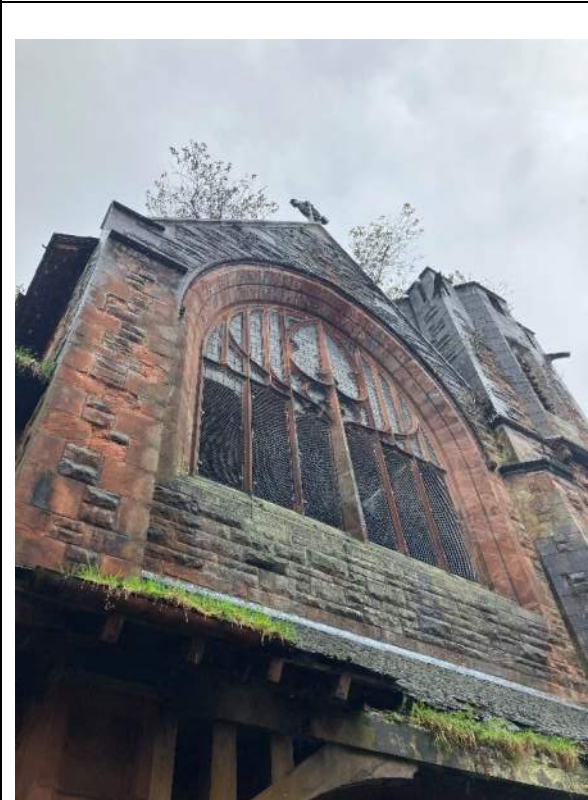
North Elevation with Canopy Damage
