<b>Report To:</b>	<b>Environment &amp; Regeneration Committee</b>	<b>Date:</b>	<b>1 June 2016</b>
<b>Report By:</b>	<b>Corporate Director Environment, Regeneration &amp; Resources</b>	<b>Report</b>	<b>ENV/13/16/AF/EM</b>
<b>Contact Officer:</b>	<b>Eddie Montgomery</b>	<b>Contact No:</b>	<b>01475 712472</b>
<b>Subject:</b>	<b>Port Glasgow Town Hall / Greenock Municipal Buildings Condition and Future Investment</b>

**Historical Restoration  
District Court  
Greenock Municipal Buildings**

**Stage 3 Report**

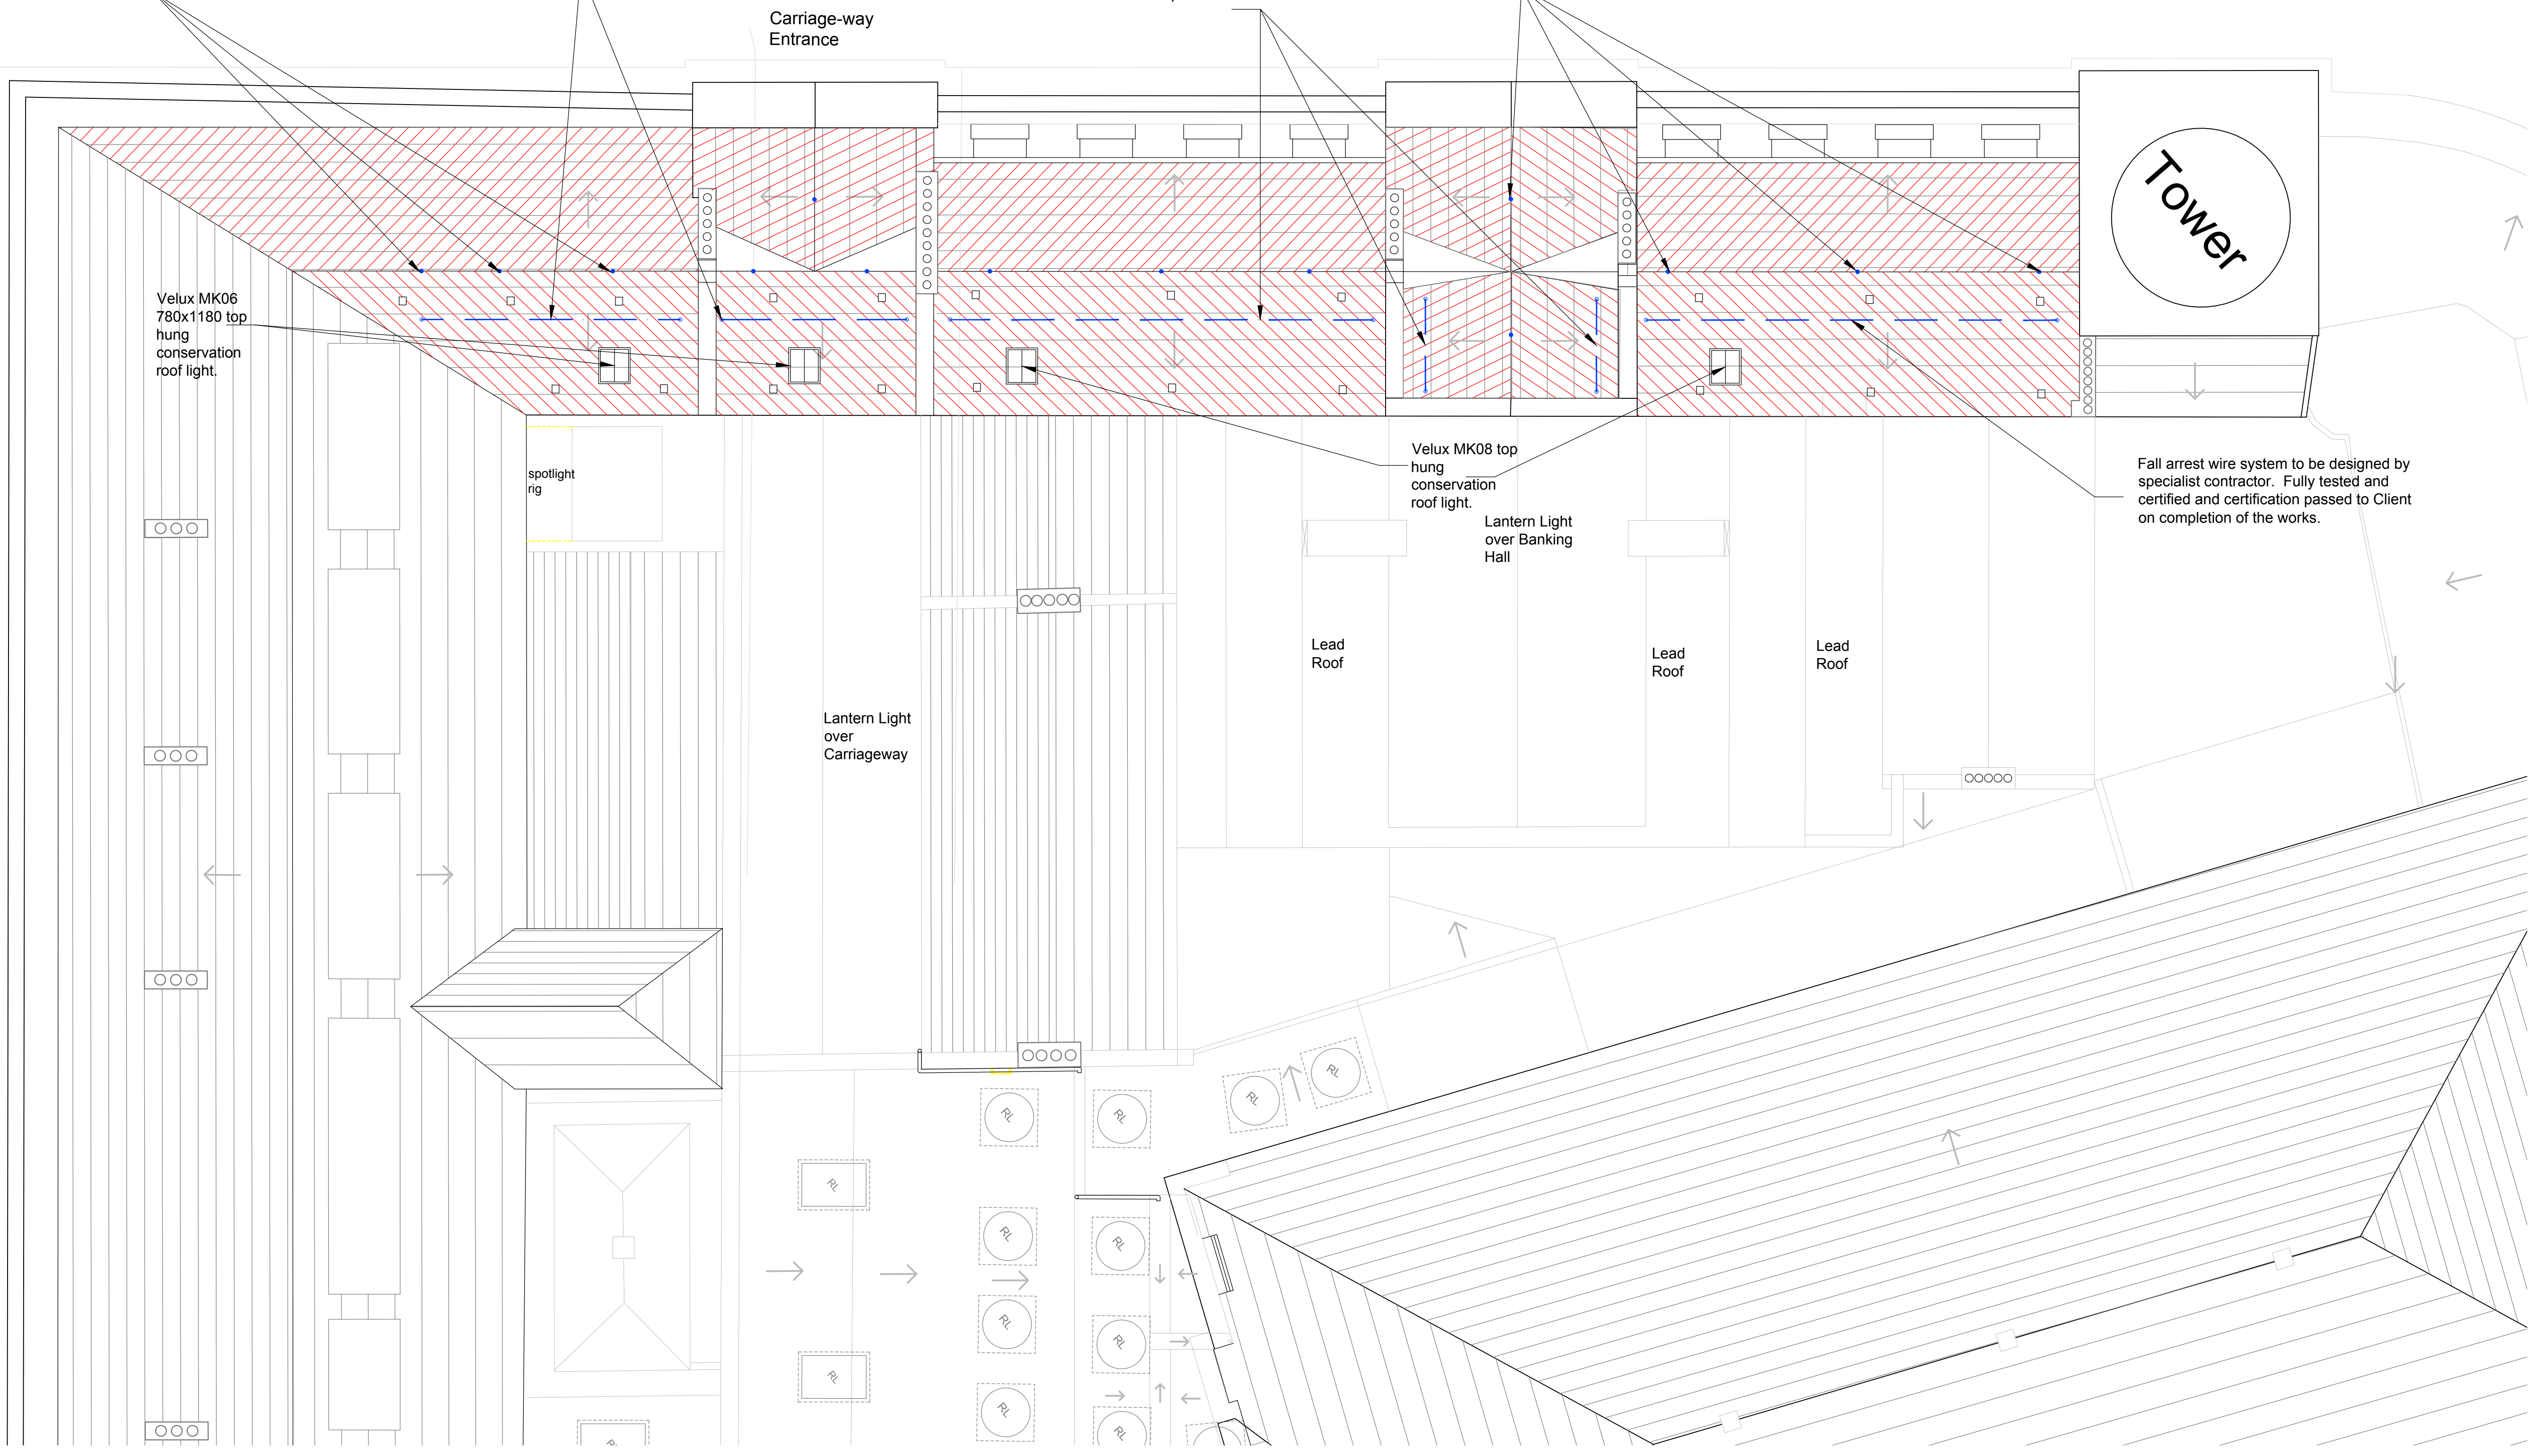
# Wallace Place

**Planning Notes Wallace Place.**

Wallace Place elevation roof slope to be re-slatted using a replacement slate selected to replicate the characteristics of the existing roof slates, this is to include thickness, texture, colour, size and grading laid on new underslate felt. Samples of proposed slates to be supplied for approval of the Planning authority.

Rear slopes can be re-slatted in new Spanish cupro slate or equal approved by the Planning Authority laid on new underslate felt. SSQ Ultra Heavy Matacota Blue-black roofing slate 7-9mm or CUPA HEAVY 3 Slate from the San Pedro quarry 7-8mm. The extra thickness and weight give it strength to withstand the high wind speeds and driving rain common throughout Scotland

The proposed replacement of damaged external decorative timber detailing to the roof dormers are to match the original detailing, this to include replication of the proportions, dimensions. All new materials, in a selected hardwood from a sustainable source.

Fall arrest wire system to be designed by specialist contractor. Fully tested and certified and certification passed to Client on completion of the works.

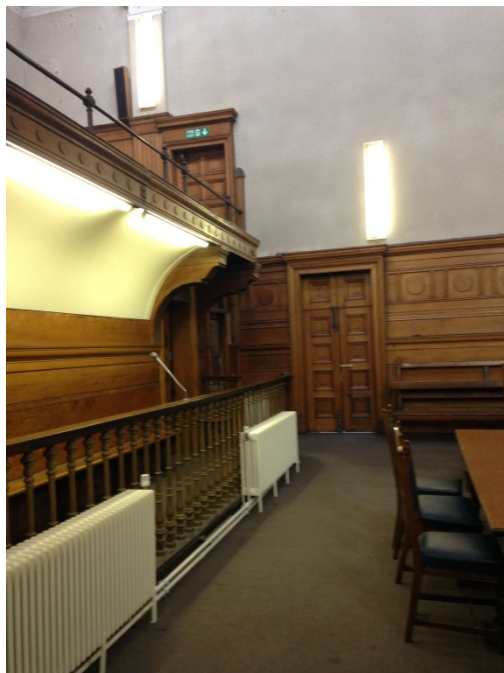
Areas of the wood work have received severe vandalism during the time it was used as Greenock's District Court. There is unsightly damage to the lime plaster work, Cornicing and Pilasters due to water ingress via the roof.

The existing Gallery balustrade is lower than would be acceptable for the current building regulations. Also, there are visible signs of what appears to be rot around some windows.

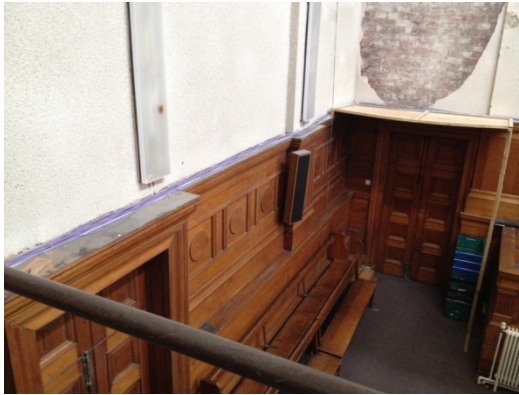
Although the existing artificial lighting scheme affords illumination that is bright enough and evenly distributed, the overall effect is bland, and very little is highlighted. The strip-lights are “cheap and functional (not cheerful)”, poor condition and colour rendering, ugly, almost industrial looking, with little aesthetic merit. Moreover, the existing fittings are not designed to be wall mounted.

They are completely unsuitable from an aesthetic point of view.
