Report To:	Environment & Regeneration Committee	Date:	29 October 2015
Report By:	Corporate Director Environment, Regeneration & Resources	Report	LPS/145/15/AMcC
Contact Officer:	Alan McClintock	Contact No:	01475 712444
Subject:	Victoria Tower – Refurbishment as Tourist Attraction

VICTORIA TOWER REPORT ON TOURIST ATTRACTION

September 2015

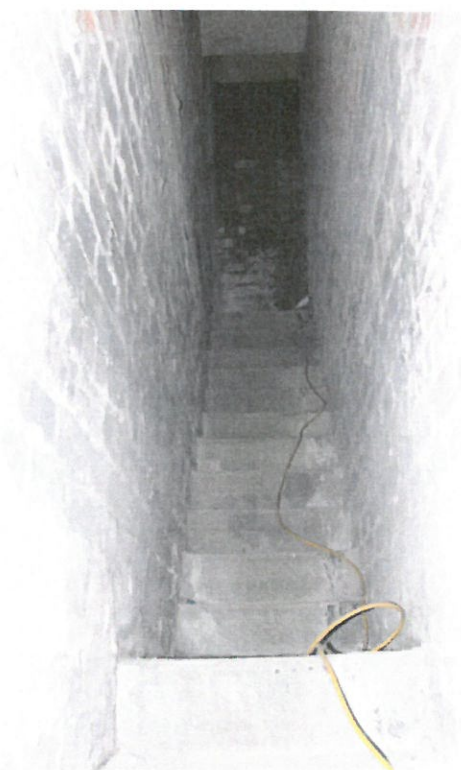
The grandeur of the Municipal Buildings and the height of the Victoria Tower was an expression of the new confidence and vitality of Greenock. The Tower however was wholly symbolic and we now understand that it was not intended for public access. The following problems exist:

- Access stairway is too narrow, has no handrail and tight corners restrict evacuation.
- The stairs are irregular and steep.
- There is no general lighting or emergency lighting.
- There are no fire doors to restrict the spread of fire.
- The mid landings can only support small groups of people.
- Windows are too small to allow alternative evacuation.

Discussions with Building Control confirmed that the Tower was not compliant primarily with regards to landings and stair risings and goings and the narrow width of the stairway. (See Appendix 1)

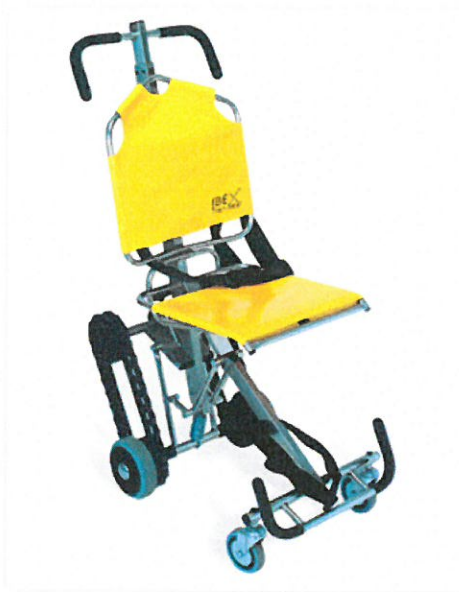
The risk of an emergency event was mitigated by the Management Plan but not eliminated. Consideration of emergency evacuation apparatus confirmed that should there be an incident, it would be impossible to evacuate a patient. The stairway is too narrow, too steep and has right angled bends that make it impossible to use a standard stretcher.

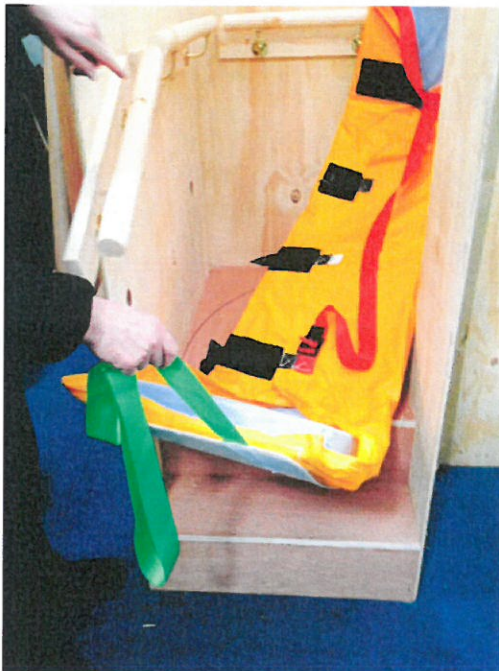
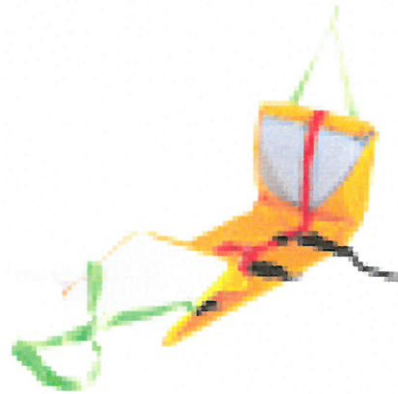
There was no suitable evacuation chair from the various selections available that could be used in the stairwell. The only evacuation mode that would function in the stairwell was the ResQmat. When this was considered in more depth and an on site assessment and trail carried out problems became evident. The staff carrying the ResQmat down the stairwell were put under extreme physical stress for a prolonged period of time. Speed was gained on descend due to the unequal risers of the stairs. The casualty in the ResQmat would more than likely be put in a lying prone position for more than 20mins creating the opportunity for suspension trauma which is not recommended and can be dangerous in itself. (See Appendix 2)

A 'mock-up' of the stair was constructed to explore the possibility of chamfering the internal corner of the Tower to ease passage round the corners but this proved to be unacceptable. (Note that it was subsequently considered structurally unacceptable to chamfer the structural wall element. See Appendix 3)

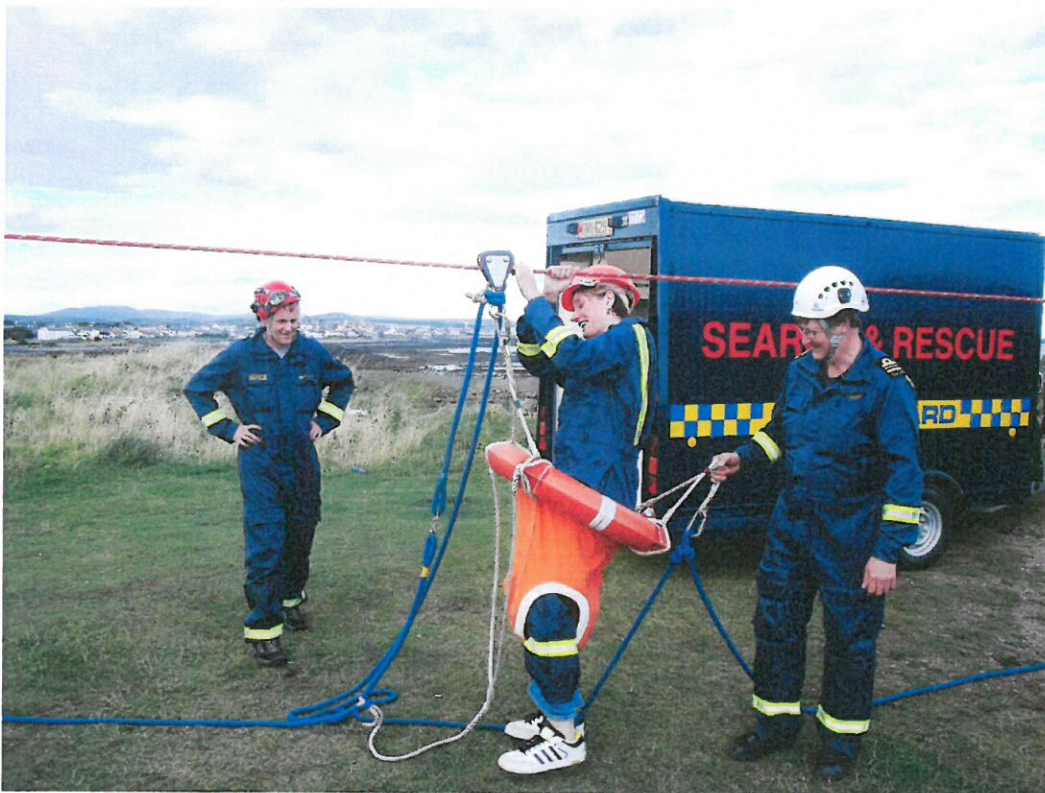
All products that have been investigated have the suspension rail level rather than on a slope as would be required to egress down the stairway. A complex braking system would be required and we could not find anything suitable on the market. A breeches buoy system was considered but this cannot turn corners. A separate line would be required for every straight run of stair and was considered impractical.

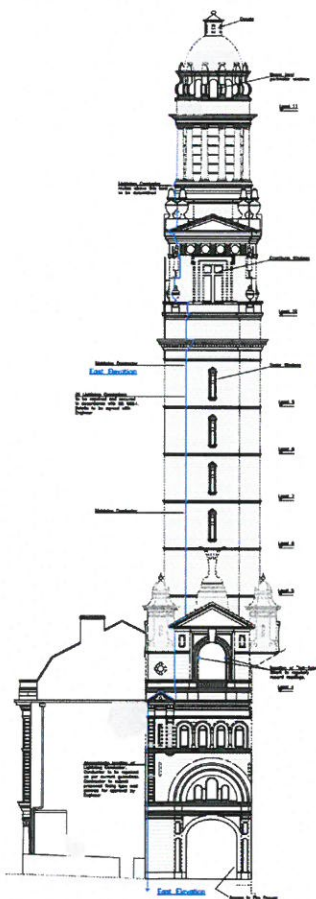
Structurally the Tower is of diaphragm wall construction with both inner and outer walls acting as load-bearing members and tied together with the stairs and landings. The intermediary floors have poor load bearing capacity and are thought to be for bracing purposes.

The windows are small and narrow and maximise the load bearing wall masonry. (Note that this also restricts the emergency egress strategy.)

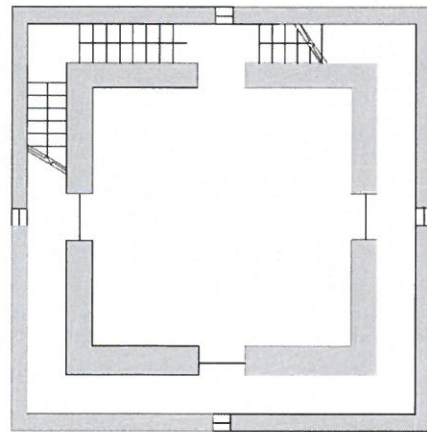
With the location of the tower and the narrow access to the upper sections it was noted that the logistics of moving materials into the tower for repair could determine the method of repair and also the extent of the repairs. With the limited access, consideration will require to be given to the access for any operatives and also for any emergencies which could occur during the works. As such, which route would an emergency exit take and how would this be kept clear at all time.

The intermediary floors were examined and it was considered that they have poor floor loading capability and probably designed as bracing to the tower structure. A further structural examination was progressed tasked with considering the replacement of these floors to provide additional floor loading ability and also to consider integrated floor hatches which could be used for emergency evacuation. The structural engineer subsequently expressed concern about destabilising the whole structure and the study was terminated. The following comments noted by the Structural Engineer:

- As described previously the internal floor is formed from cut brick and masonry bound together with concrete, in order to form a void through the floor we would recommend that steel trimmers are placed around the floor opening in order to provide support to the floor. Within a number of the upper floor levels, the existing steel beams providing support to the floor are badly corroded and would need to be replaced as part of these works

- The existing floor provides a horizontal restraint to the overall structure via diaphragm action therefore the formation of a void within the floor will reduce the capacity of the floor to provide restraint to the overall superstructure

- The existing floor has not been designed for the loads that would be experienced as an exhibition space in accordance with current guidelines and design standards and under such loadings the floor would fail under design analysis.
