**Report To:** Safe, Sustainable Communities Committee      **Date:** 30 August 2011  
**Report By:** Corporate Director Education & Communities      **Report No:** SCS/69/11/AH/DH  
**Contact Officer:** Drew Hall      **Contact No:** 714272  
**Subject:** **Council's Duties Under Mines & Quarries Act 1954**

## **Investigation and hazard assessment of abandoned mines and quarries**

**Inverclyde**

**September 2010**

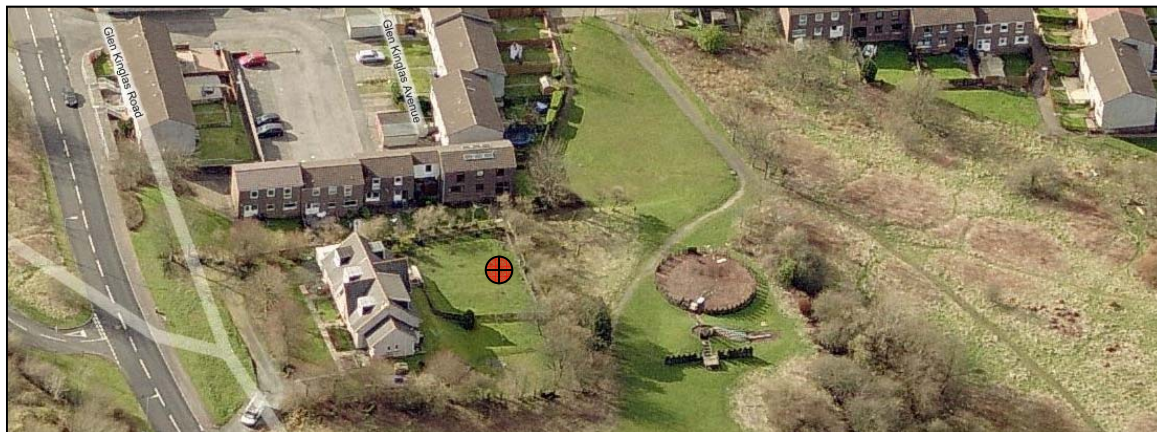
#### **Overton Air Shaft looking westward across site**

A site visit was carried out at the Overton Air Shaft (SW1) on the 17<sup>th</sup> August 2010. Photographs from the reconnaissance are contained in Appendix F.

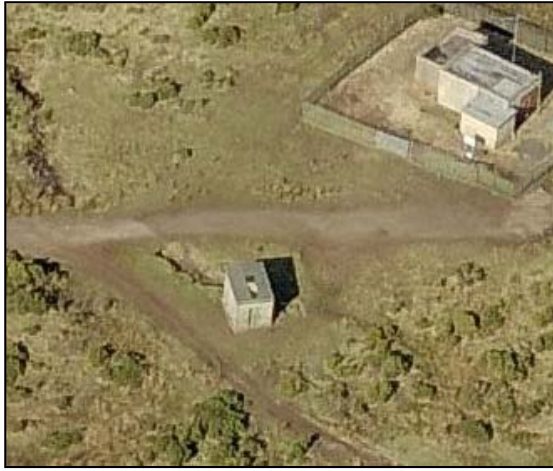
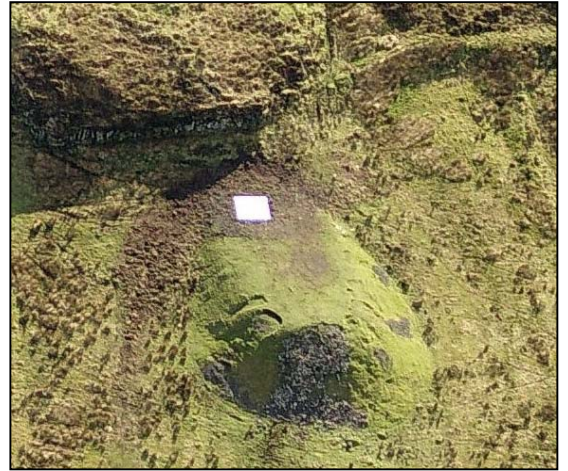
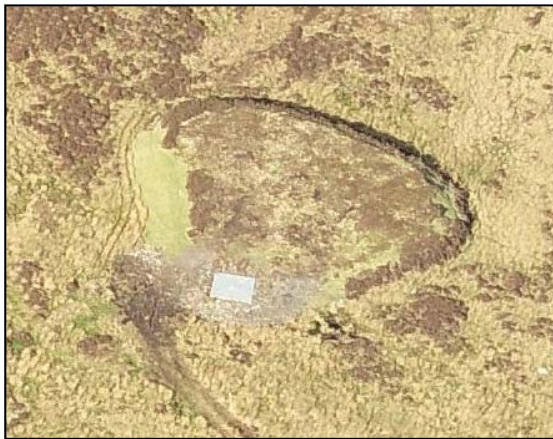
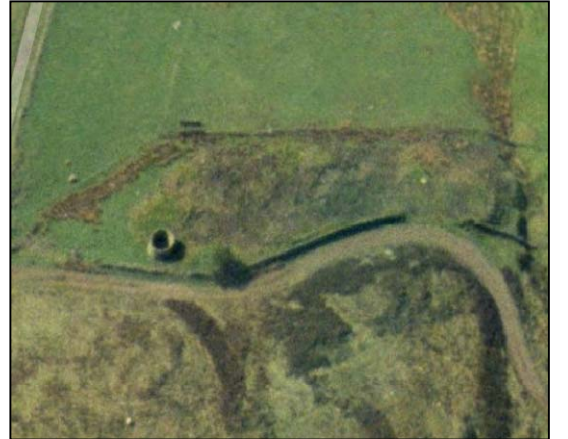
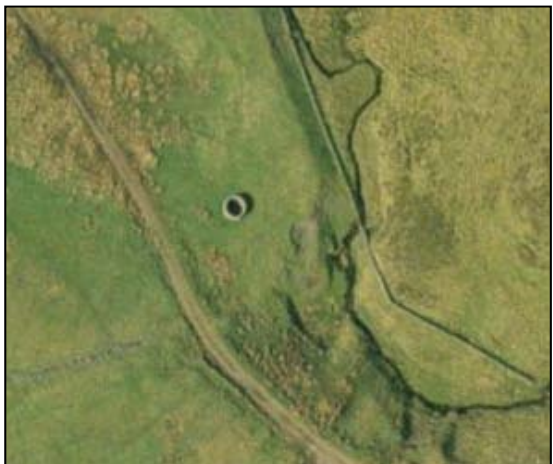
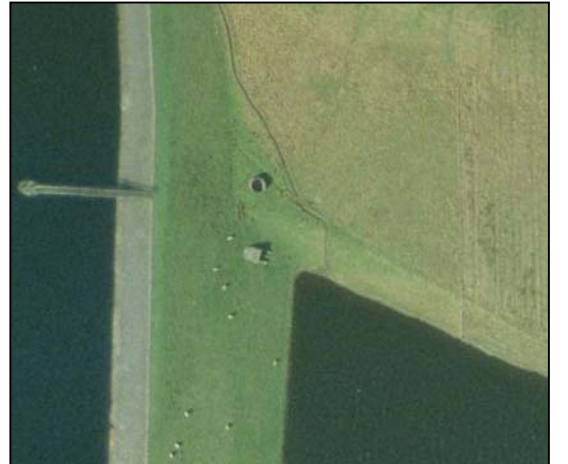
**Aerial Photographs for Air Shafts SW2 to SW7 (circa 2007)**

Air shafts, **SW2** to **SW7** are in a linear arrangement and appear to be associated with a water culvert from the Gryfe Reservoirs to Whinhill water supply treatment works. Given that the system is still in use for public water supply, it is considered most likely that the maintenance of these features is the responsibility of Scottish Water.

The aerial photographs show the entrance to air shaft SW2 to be housed within a small building, SW3 and SW4 are concealed by a square cover at ground level. The air shaft opening at SW5, SW6 and SW7 is enclosed by a circular wall. This is likely to have been part of the original construction. It is not known if these circular features have a safety mesh or cover within them, or if the height would effectively prevent public access. Furthermore, the structural condition of each feature is unknown.

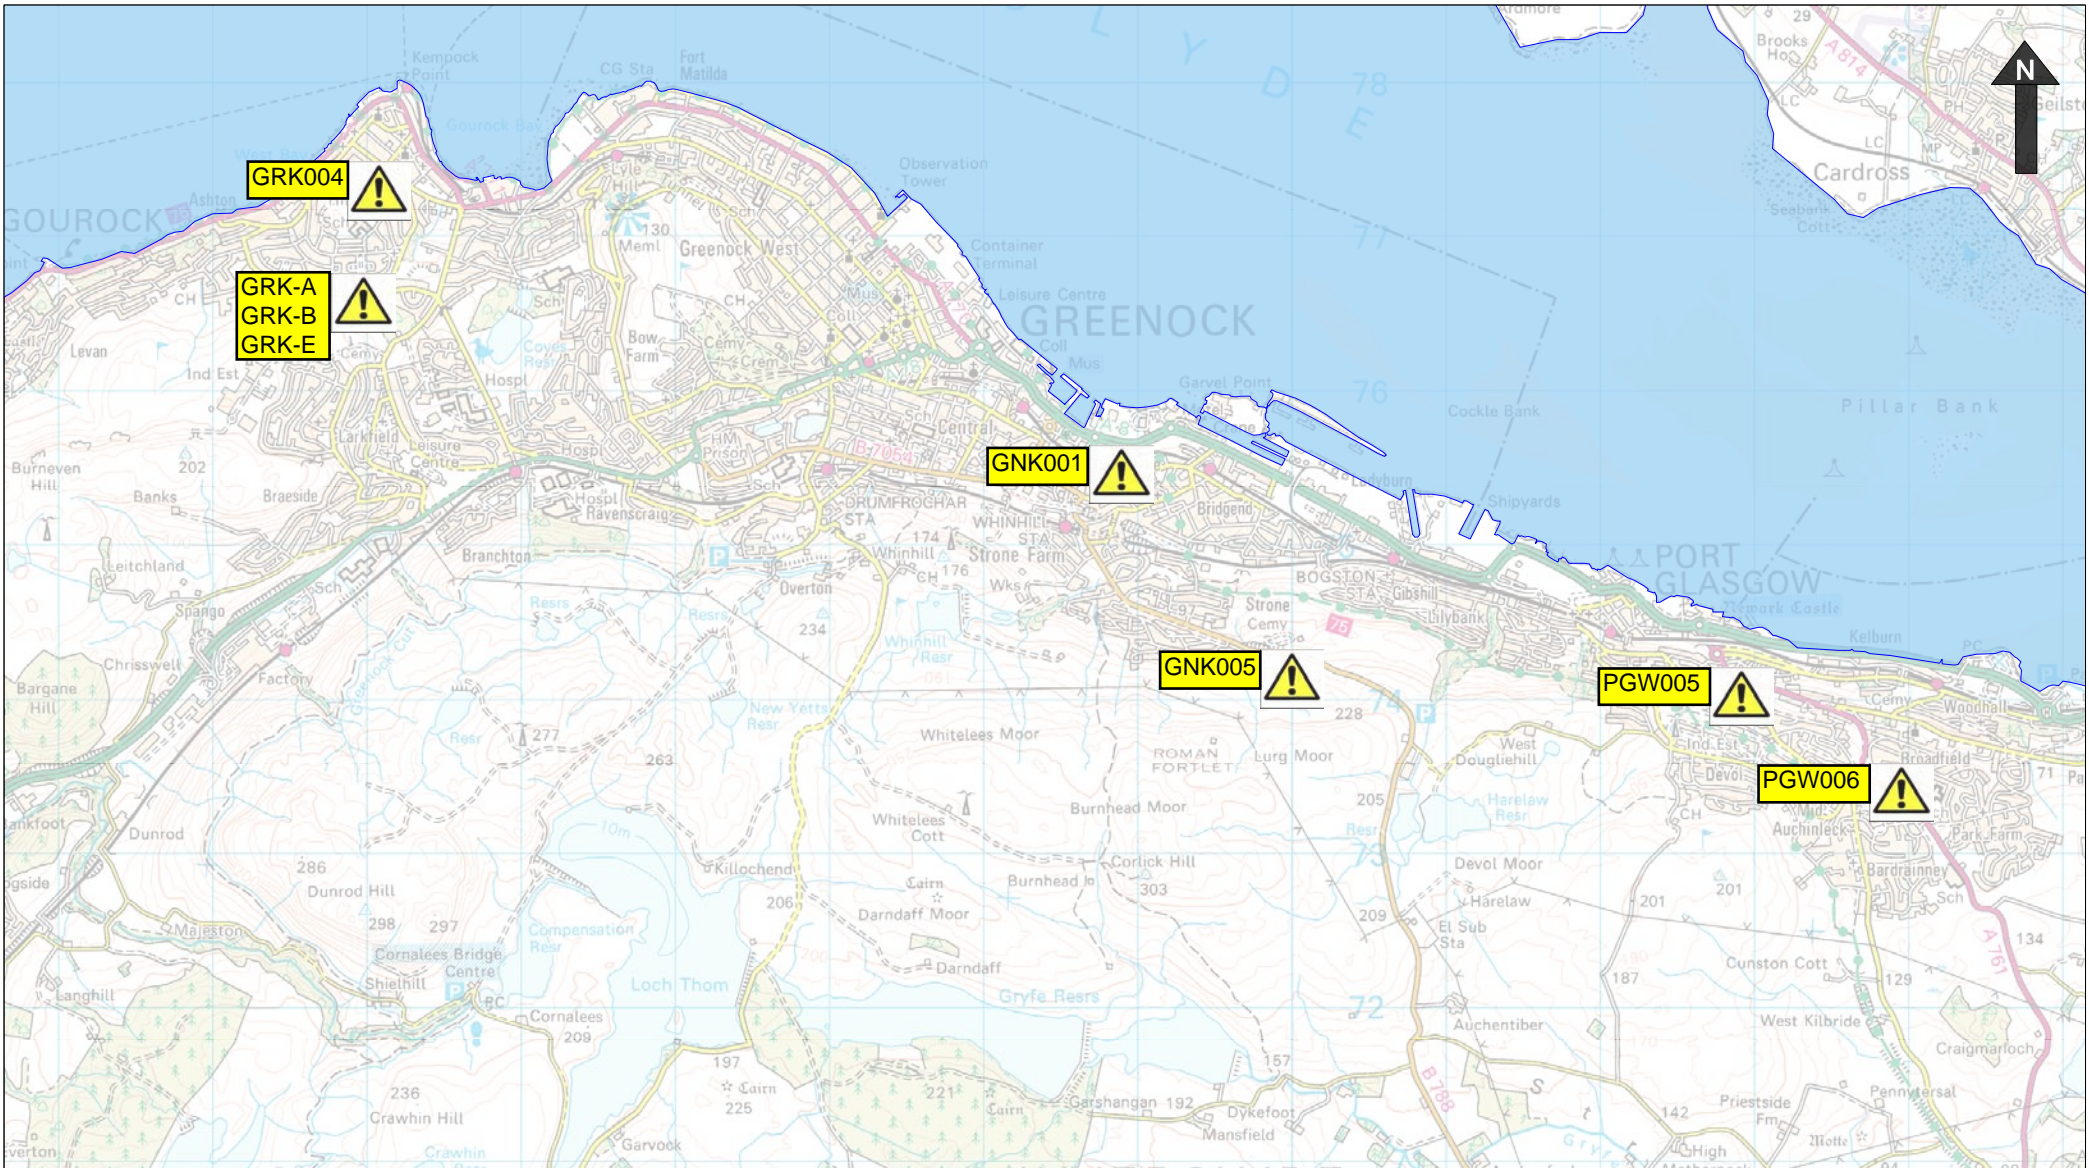
**Figure 10 - Map of Abandoned Mine Shaft and Quarry Hazards**

Ref	Location	Hazard	Intervention Action
GRK-A	Mine Shaft	Subsidence	Regular monitoring
GRK-B	Mine Shaft	Subsidence	Regular monitoring
GRK-E	Mine Shaft	Subsidence	Regular monitoring
GRK004	Craigmuschat Quarry / Landfill	Fall from height, rock fall and subsidence	Regular monitoring, secure quarry cliff edge and/or warning signage.
GNK001	Cartsdyke Quarry	Fall from height	Secure quarry cliff edge and/or warning signage.
GNK005	Auchmountain Quarry	Fall from height and rock fall	Secure quarry cliff edge and/or warning signage.
PGW005	Clune Brae Quarry	Fall from height and rock fall	Secure quarry cliff edge and/or warning signage.
PGW006	Bardrainey Quarries	Fall from height	Secure quarry cliff edge and/or warning signage.

The assessment has highlighted hazardous abandoned mines and quarry sites requiring further consideration with respect to ensuring public health protection. These sites are listed in table 7.1 and shown on a hazard location plan (Figure 10).

Officers of this Service will identify and liaise with the persons responsible and relevant stakeholders, to ensure adequate protection measures are put in place. Officers will thereafter be required to periodically inspect these sites to review the hazard assessment and ensure protection measures are maintained.
