Report To:	Environment & Regeneration Committee	Date:	29 October 2020
Report By:	Corporate Director Environment, Regeneration & Resources	Report No:	ENV/029/20/AM
Contact Officer:	Alan McClintock	Contact No:	01472 712444
Subject:	Comet Replica – Condition Survey

General Condition Survey

Comet Replica

Project No: 2090/00

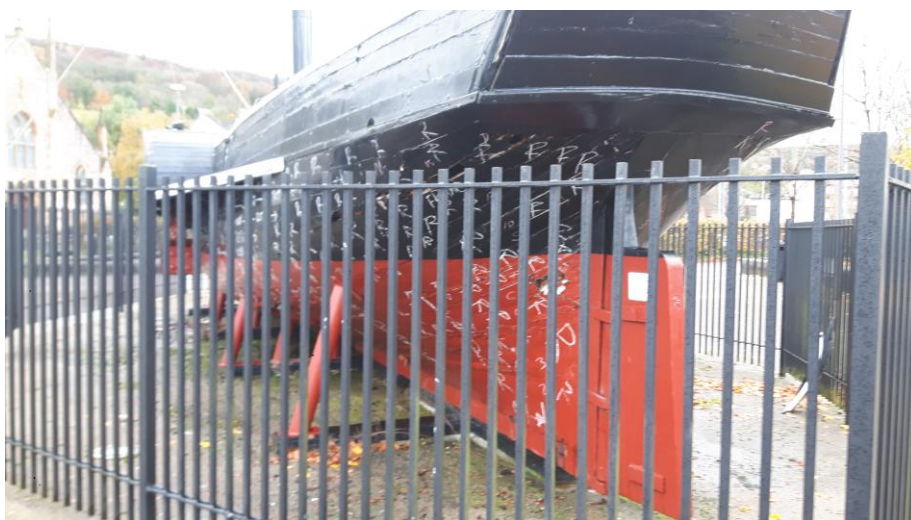
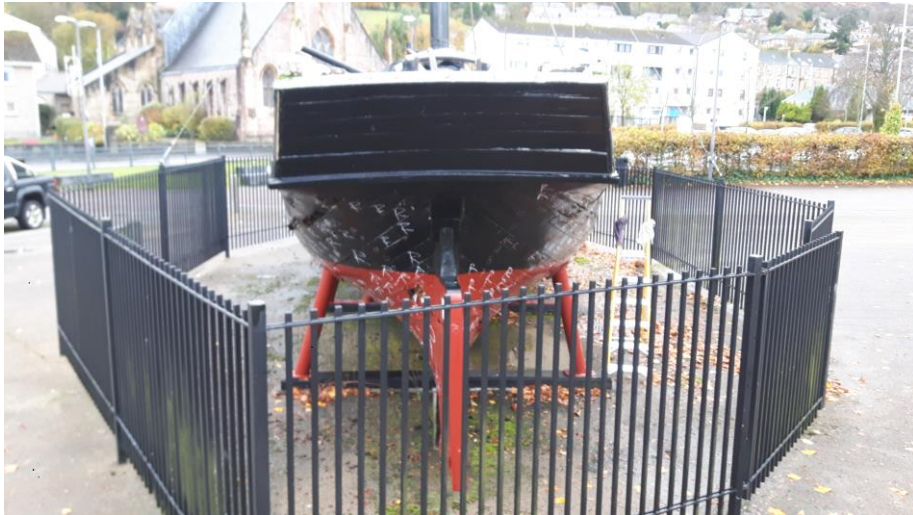
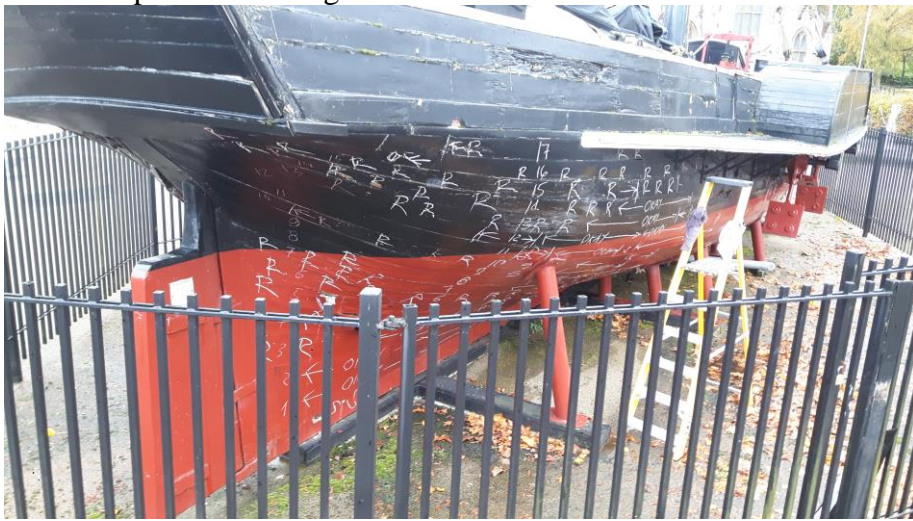
Comet Replica Port Glasgow

The vessel is mounted behind a secure steel fence in Port Glasgow town centre pedestrianised area, there is no public access on board the vessel. The vessel is open to the elements and the West of Scotland weather which generally consists of a lot of rain and wind with very cold spells in the winter.

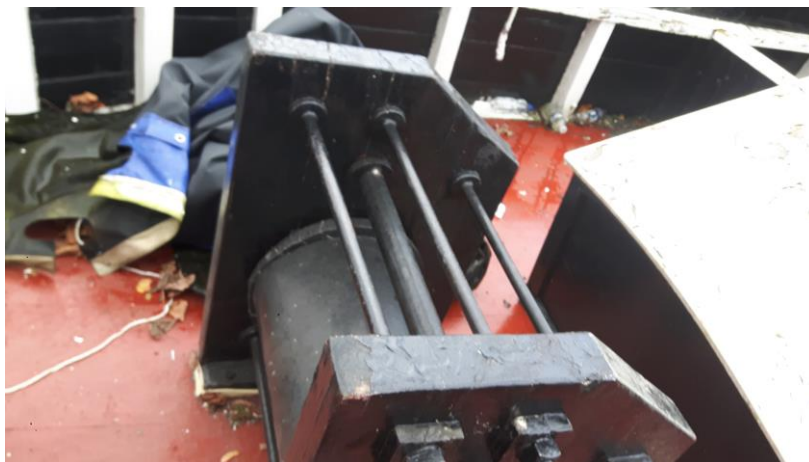
Timber windlass

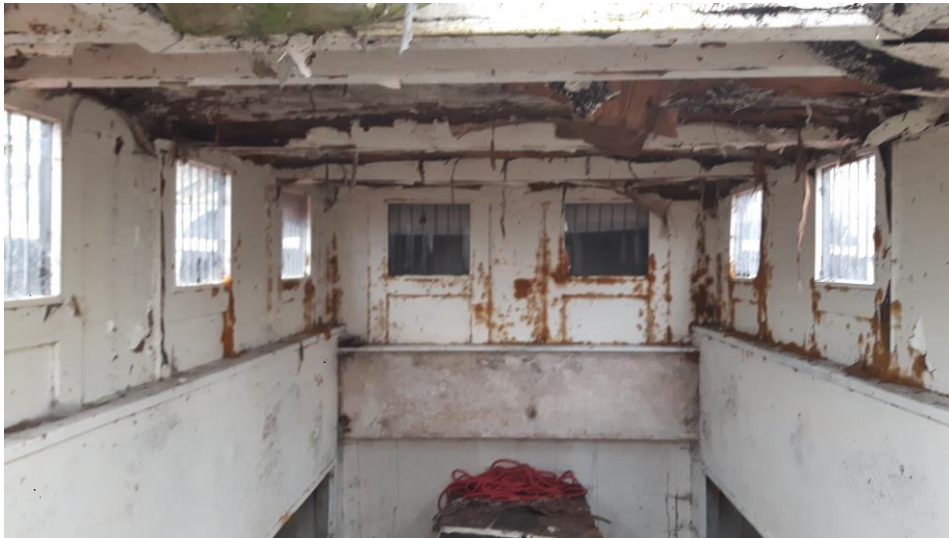
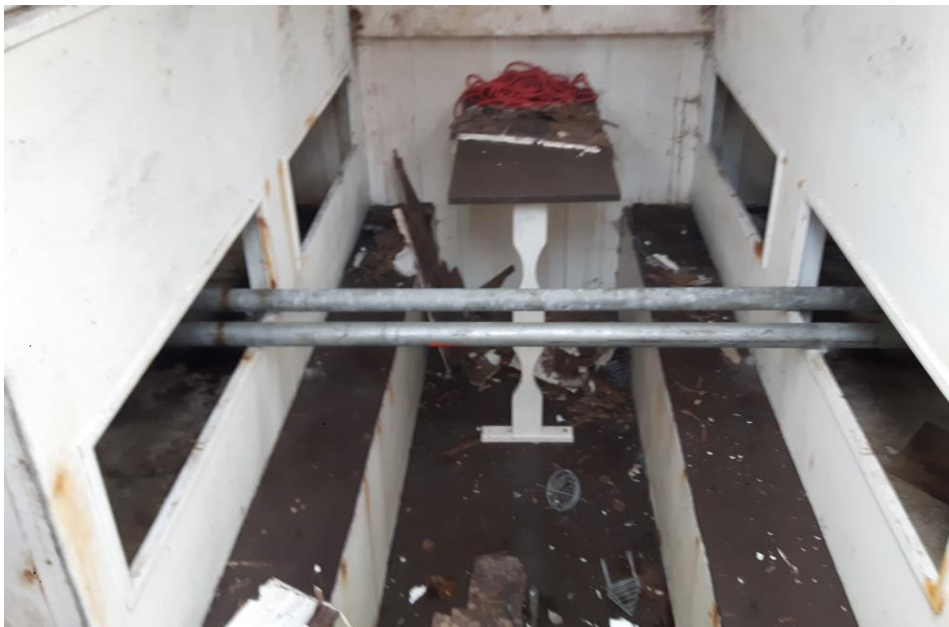
Aft cabin

The aft cabin is fitted with 4 bunks, bench seats and a table, most of the outfitting is plywood.

There is no ventilation on the vessel and it is now too late to fit any ventilation as the material condition is so poor.

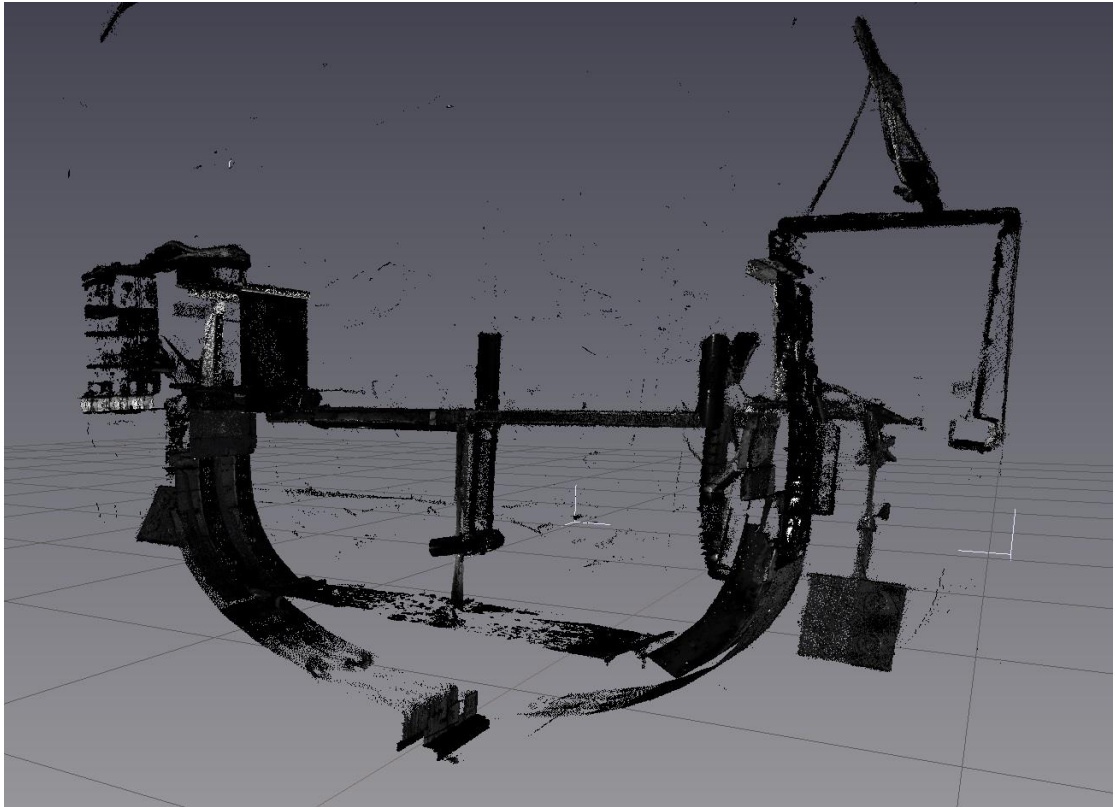
There are two paddle wheels on each side of the vessel, the paddle wheels are in okay condition. The gear wheels driving the paddle wheels are no longer meshing or not meshing correctly due to the twist in the hull and the rotten machinery foundations. Most of the timber in the paddle boxes is rotten..

Iso view in way of rear paddle wheel

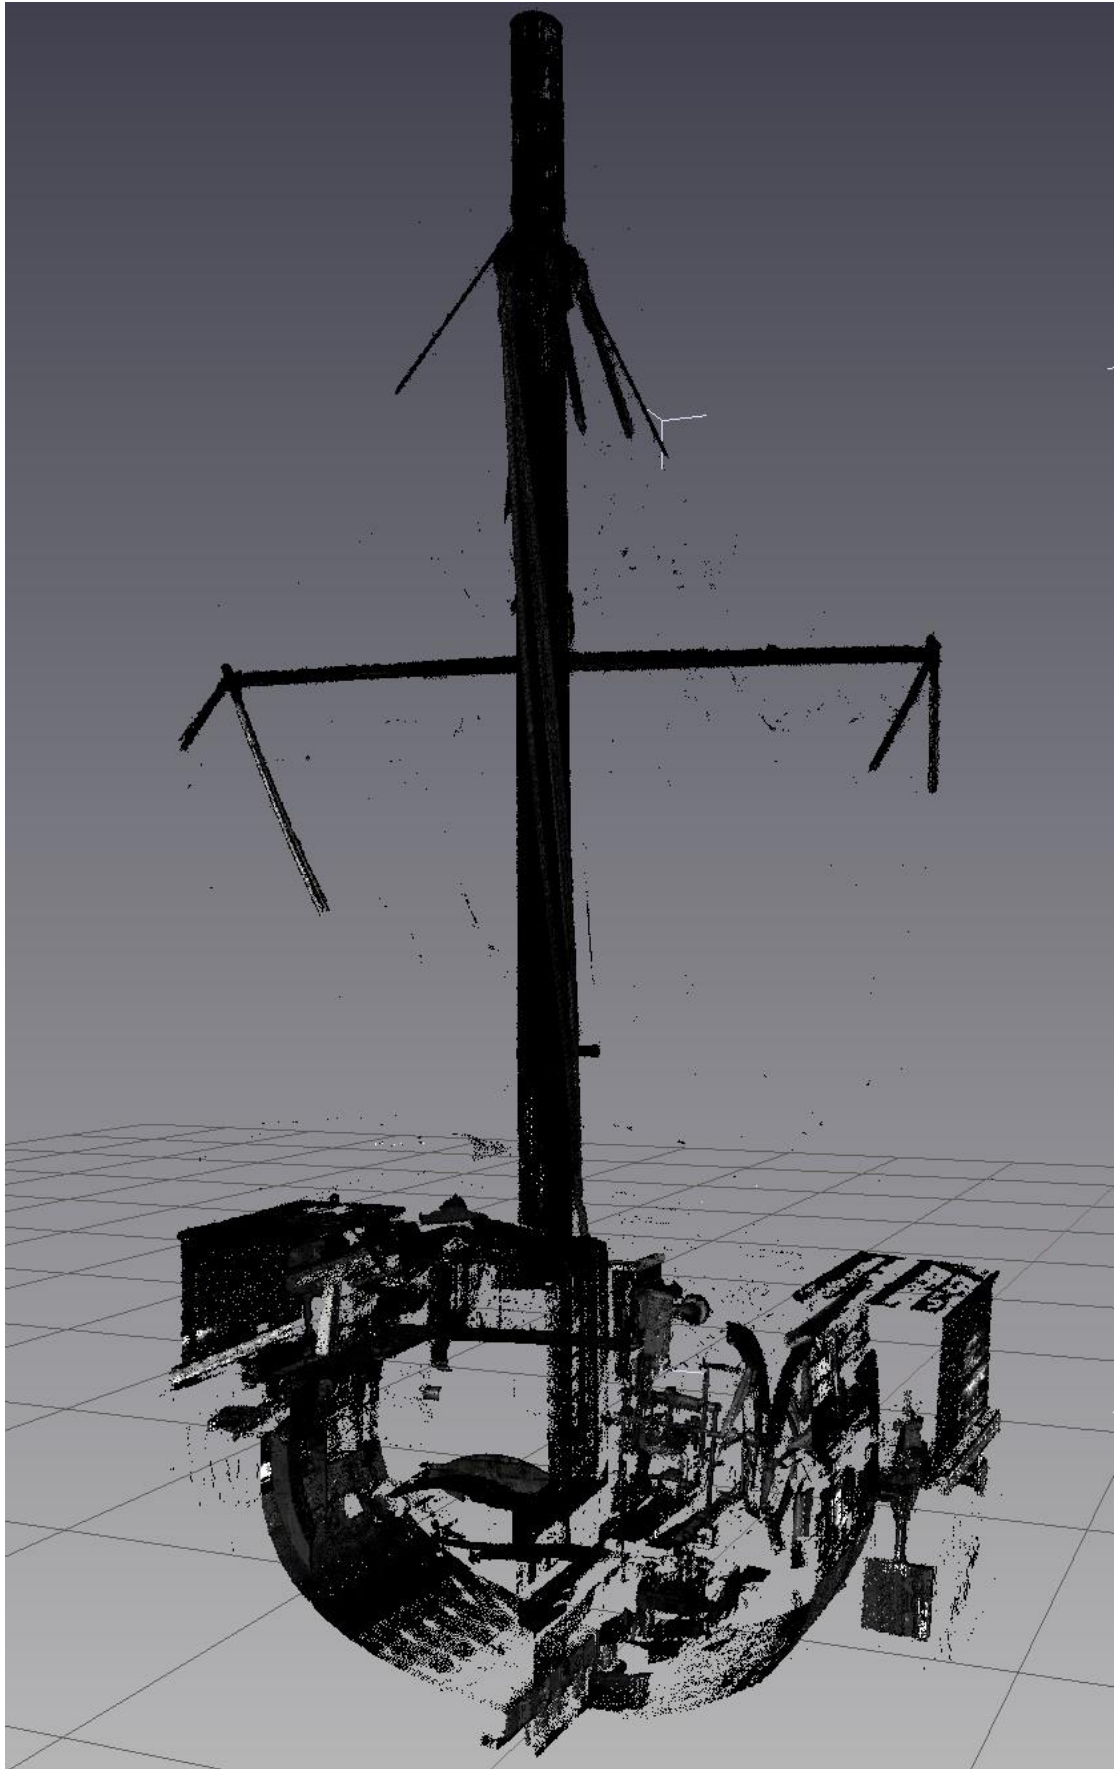
The main engine is a John G Kincaid single cylinder steam engine, powered by a saddle type boiler. Engine is completely seized. It is thought the engine, boiler, paddles and gearing could be removed from the vessel and fitted in a new replica, the boiler, engine, paddles etc would require stripping, cleaning, preserving and reassembly to ensure longevity. While it is probably not worth returning the machinery to working condition it is definitely worth returning the machinery to display condition, possibly having the machinery (engine and paddle wheels) driven by an electric motor.

Iso view in way of engine
