<b>Report To:</b>	<b>Environment &amp; Regeneration Committee</b>	<b>Date:</b>	<b>1 June 2016</b>
<b>Report By:</b>	<b>Corporate Director Environment, Regeneration &amp; Resources</b>	<b>Report</b>	<b>ENV/13/16/AF/EM</b>
<b>Contact Officer:</b>	<b>Eddie Montgomery</b>	<b>Contact No:</b>	<b>01475 712472</b>
<b>Subject:</b>	<b>Port Glasgow Town Hall / Greenock Municipal Buildings Condition and Future Investment</b>

**Historical Restoration  
District Court  
Greenock Municipal Buildings**

**Stage 3 Report**

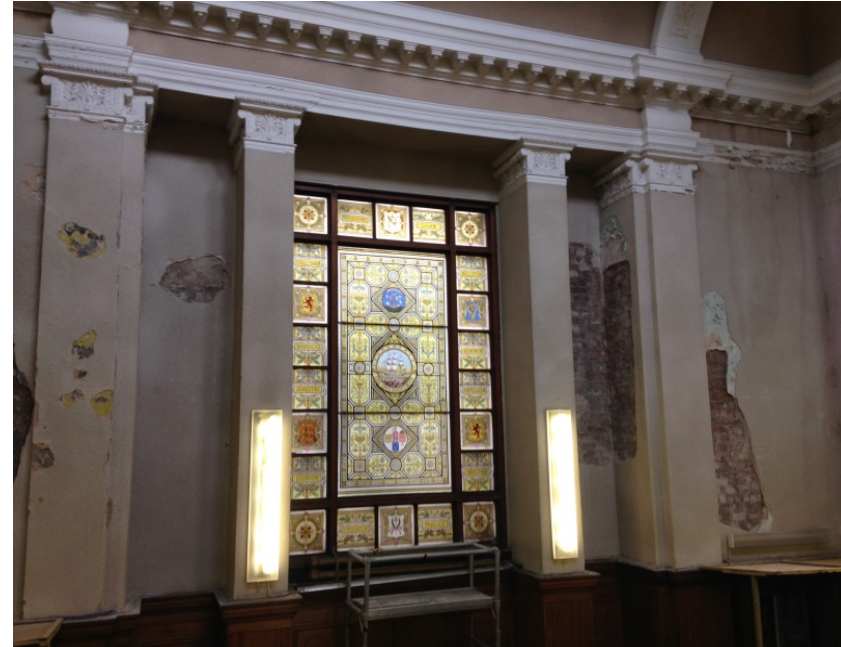
### 5. Plasterwork, Cornices and Pilasters

Water ingress, via the roof, has damaged the ceiling and wall plasterwork. The original lime plaster has been coated in an aertex type acoustic plaster. We would remove this coating, repair the

plasterwork using the Scottish Lime Centre's specification and decorate. Repair and restoration work would also be required using the Scottish Lime Centre's specification to the narrow cornicing, feature cornicing, isolated repairs to the ornate ceiling and renewal of a section of the lathe and plaster vaulted ceilings. As the cornices and decorative plaster shows signs of water staining and investigation will be necessary to ensure their stability.
